STRUCTURAL CONDITION ASSESSMENT

RODNEY RESERVOIR

**8TH AND RODNEY STREETS
WILMINGTON, DELAWARE**

**DEPARTMENT OF PUBLIC WORKS
City of Wilmington**

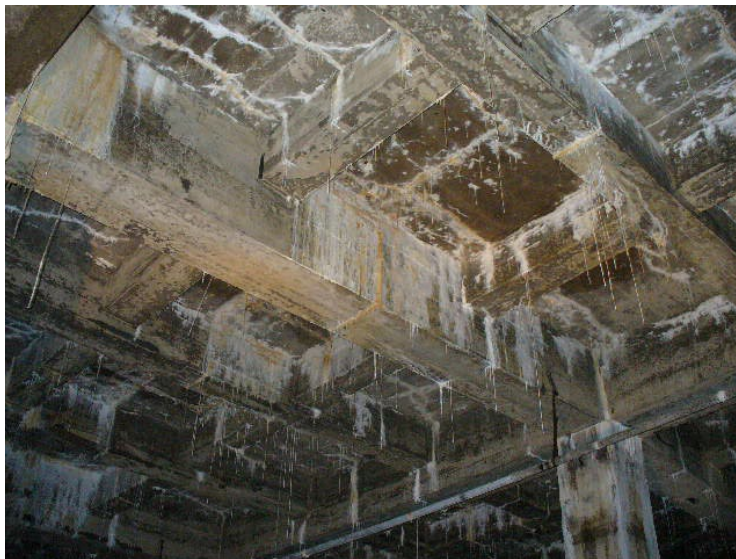
A visual survey of the underside of the roof reveals that concrete deterioration has advanced throughout the roof section that supports the paved areas - cracking is pervasive. The roof section is saturated with moisture with droplets of water forming over the entire surface of the bottom of the elevated deck. Evidence of the migration of moisture through the cracks in the concrete deck is witnessed by efflorescent staining and exudations that have formed stalactites, some 4' in length, hanging from the underside of the deck and originating in the cracks. Directly below the stalactites are hard, knobby stalagmite formations which rise several inches above the concrete floor level. These calcium carbonate deposits are the result of the dissolution of cement hydration products by water migrating through the concrete. Once the water reaches the bottom surface, the drops of moisture evaporate, leaving the lime deposit.

*Deterioration of roof slab below paved areas in the west section
Gredell & Associates, 13 July 2006*

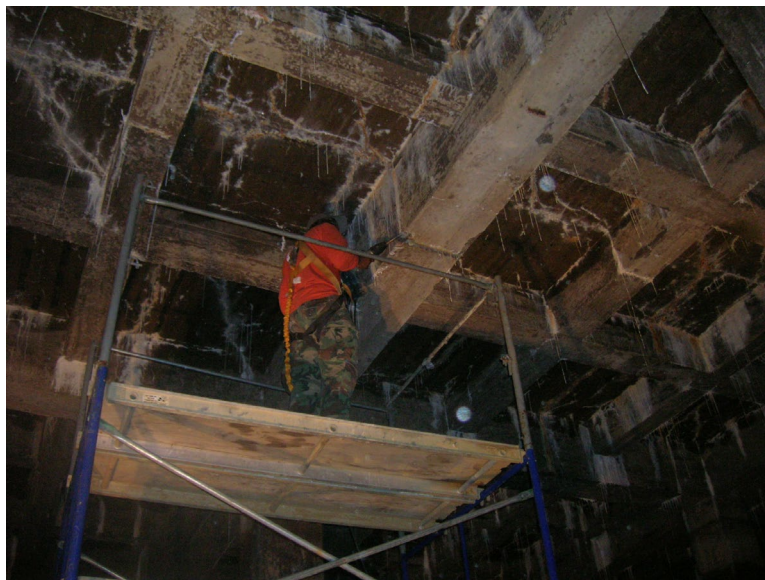
cracking occurs in the surrounding concrete. The cracking weakens the section to the extent that it fails; exposing the corroded reinforcement steel. Working with an electric powered chipping hammer, probes were made in the concrete to expose sections of the underlying reinforcing steel. Typically, the positive (bottom) reinforcing steel in the girders and the beams showed only mild signs of corrosion; however, the reinforcing steel in the 6" deck slabs is actively corroding. Accordingly, it is reasonable to assume that the negative (top) steel in the girders and the beams has been adversely affected by the moisture in the slab section.

*Probing the concrete girder with electric chipping tool to observe reinforcing steel
Note: probe being made at construction joint
Gredell & Associates, 31 August 2006*

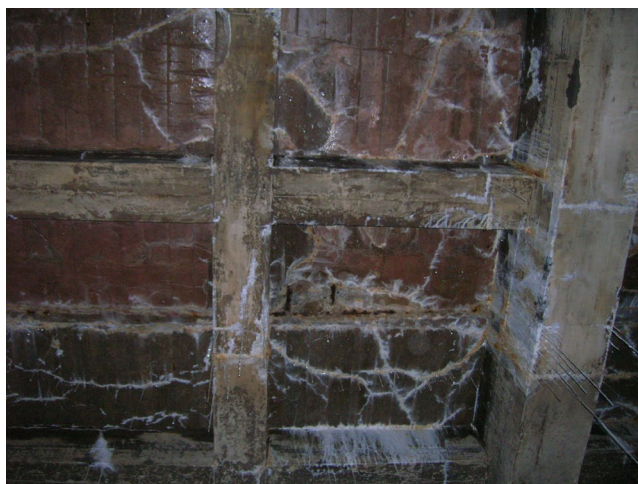
The visual surveys revealed areas of reinforcing steel corrosion as witnessed by the brown coloration of the stalactites and the spalling of the concrete. The spalling is caused by the corrosion of the reinforcing bar – the volume of the byproducts of corrosion are approximately double that of the original section. As a result of the expansion, tensile

*Spalled concrete exposing corrosion of the reinforcing steel
Note: construction joint provides path for water / anode formation
Gredell & Associates, 21 September 2006*

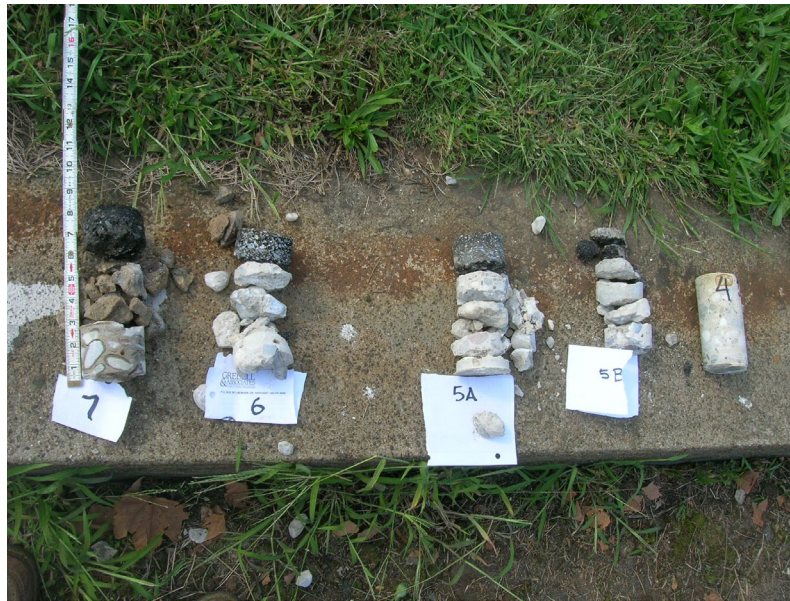
Cores 4 and 5B were sent to the laboratory for testing

*Note: freeze-thaw delamination and bituminous pavement for all cores except #4
Gredell & Associates, 31 August 2006*

The cores, both 3 and 5B, contain extensive visual cracking. The cracks transect and circumscribe the aggregate particles and are oriented parallel to the surface. The cracking extends through the full depth of the core. The cracking has been caused by cyclical freeze-thaw of water that has saturated the concrete section and a lack of air- entrainment. Core 4 taken towards the west side of the reservoir below the grassed area contains no visible cracking. Core 3, although taken from below the grassed area, does show signs of cracking due to freeze-thaw action. A compression test performed on core 4 revealed that the non- deteriorated concrete is extremely strong with a breaking strength of 6186 PSI (ASTM C42). For the samples taken from below the paved areas there is clear evidence of extensive moisture migration as witnessed by the precipitation of secondary ettringite, calcium carbonate and alkali –silica gel deposits found in the cracks and voids of the samples reviewed under the microscope. The concrete is determined to be of poor quality.
