# SOUTH WILMINGTON DRAINAGE STUDY

Prepared by  
**Rummel, Klepper & Kahl, LLP**

**For the City of Wilmington, Department of Public Works**

Subject: Final Engineering Report

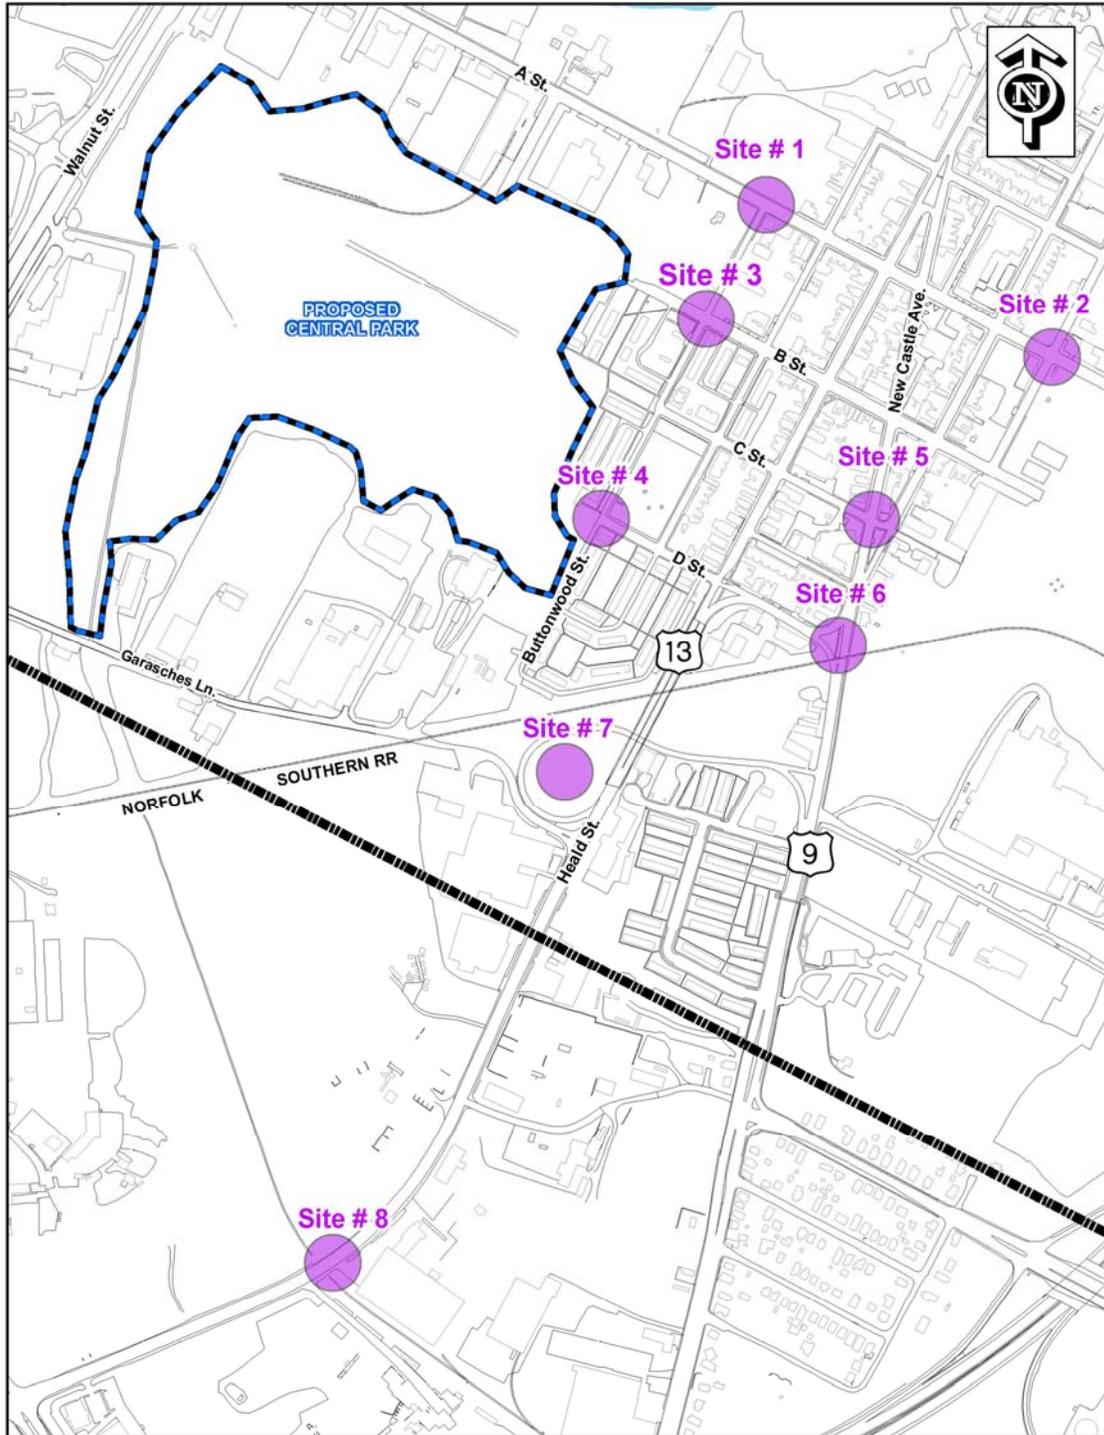
FIGURE 2

The locations of the drainage problem areas are depicted on Figure 2 on the following page. A larger scale version of Figure 2 is Appendix A.

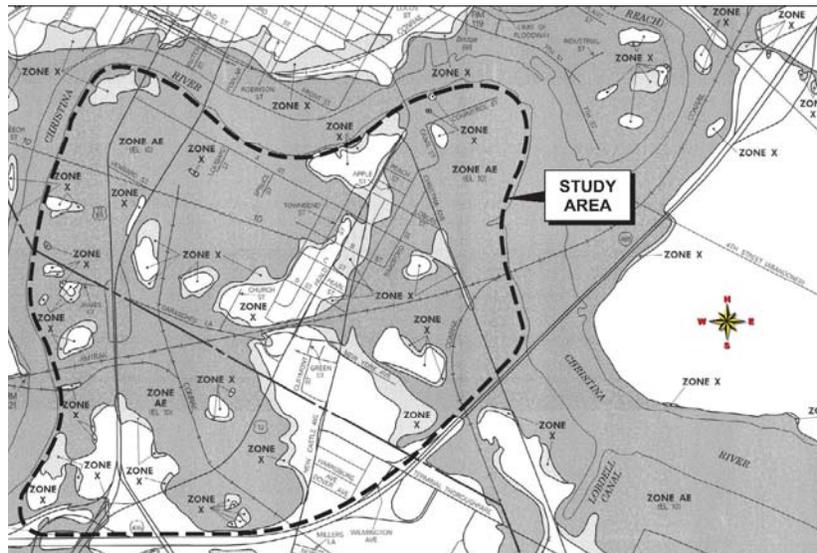
A significant portion of the South Wilmington Area lies within the 100-year floodplain of the Christina River. The Federal Emergency Management Agency (FEMA) floodplain map is depicted below and as Figure 3 in Appendix A. The 100-year flood elevation estimated by FEMA is 8.8 feet based on the North American Vertical Datum of 1988 (NAVD88).

FEMA Floodplain Map

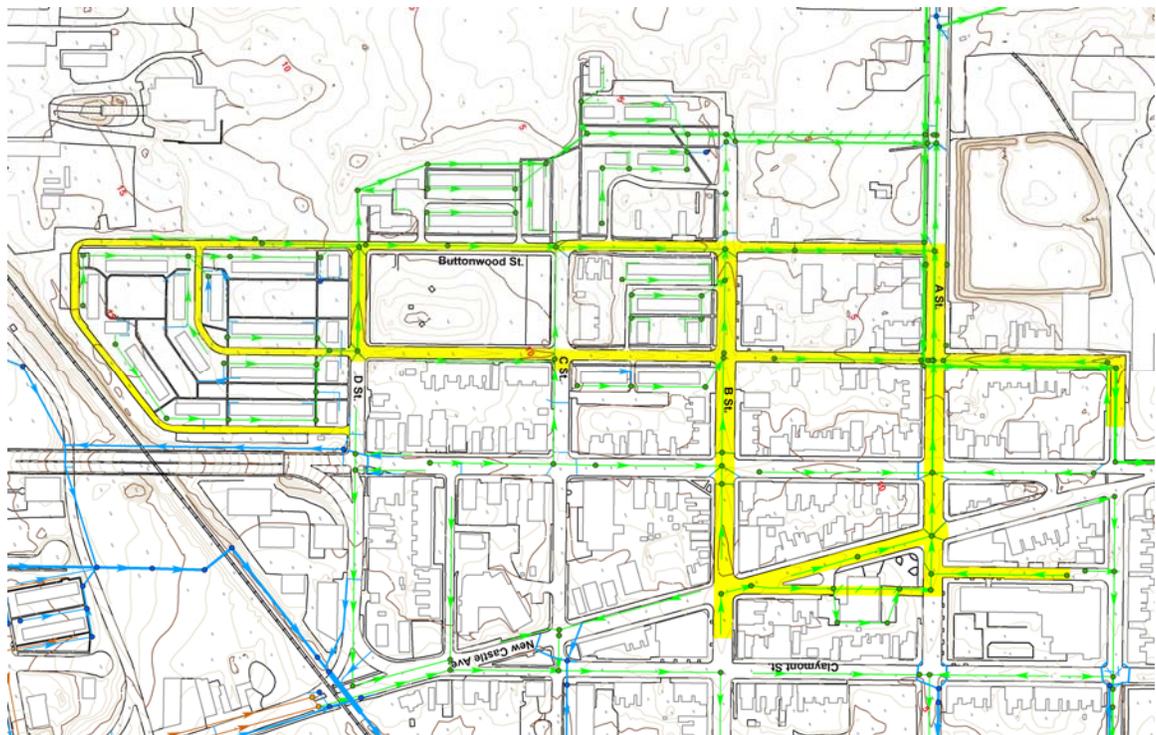
This drainage area is depicted below. The streets highlighted in yellow indicate the areas of combined sewers that drain to CSO 10. The total drainage area of the 24-inch combined sewer is approximately 42 acres.

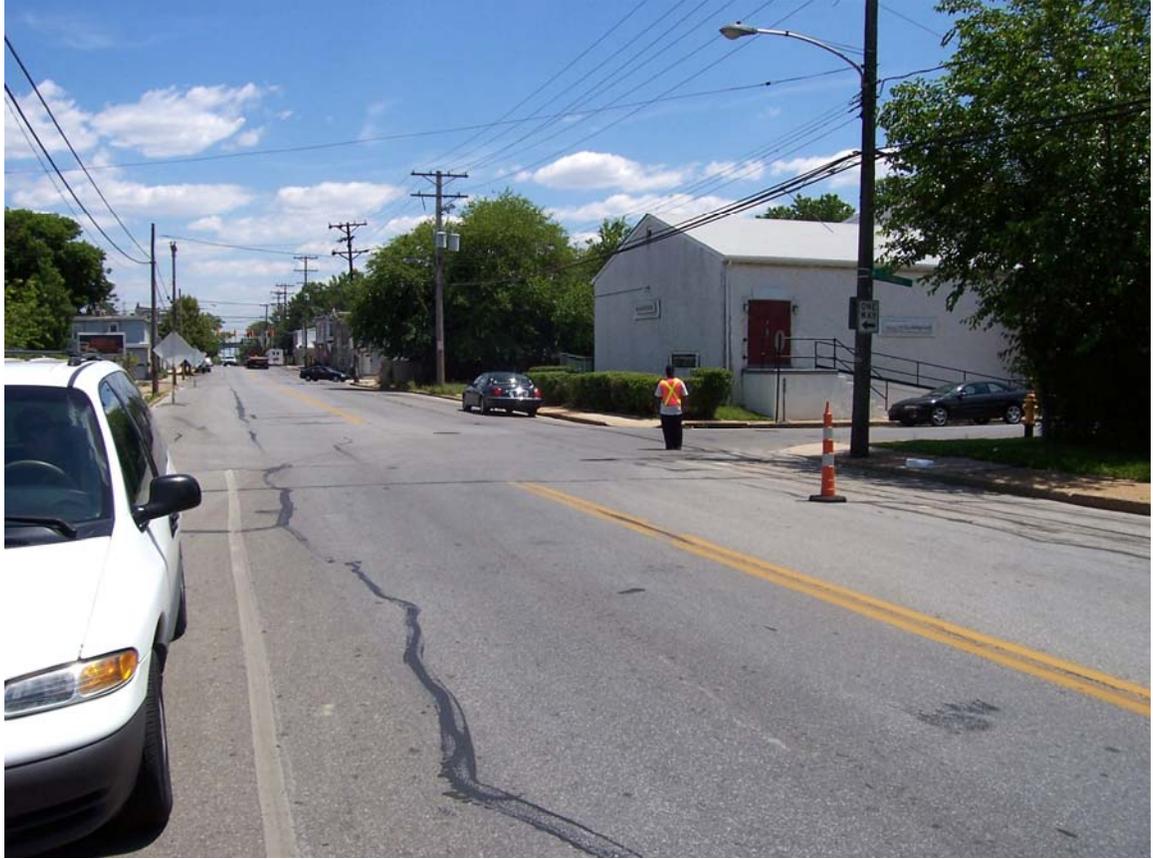
The inlets at Buttonwood and Locust Streets connect to a 24-inch combined sewer in the middle of A Street which connects to combined sewer overflow (CSO) 10 at Locust Street. Under normal conditions, the flows in this 24-inch combined sewer travels west until it reaches CSO 10 and then enters Interceptor DW, a 36-inch combined sewer traveling east along the south side of A Street. If Interceptor DW is surcharged, however, the flow would then overtop the weir in CSO10 and flow into a 24-inch drain which joins a 48-inch pipe approximately 250 feet to the west which ultimately discharges into the Christina River. There is a tide gate at the end of this 48-inch pipe at the Christina River.

A Street at Buttonwood Street

Recommendations for Sites 1, 3 and 4 are provided together since these three sites are located within the same drainage area and all drain to CSO 10. A lack of hydraulic capacity in the combined system is the most apparent cause of the drainage problems at these three sites. To solve these problems, the most effective solution would be to separate the combined system within this drainage area. The majority of this drainage area is located within Southbridge. The *March 2006 South Wilmington Neighborhood Plan* indicates that this area is planned for neighborhood revitalization. It is also possible to separate a portion of the total drainage area, although the benefits would obviously be less than total separation. The storm runoff could be diverted into the proposed central park which will be used, at least in part, as a stormwater retention area. The proposed improvements are depicted on Figure 11 in Appendix A.

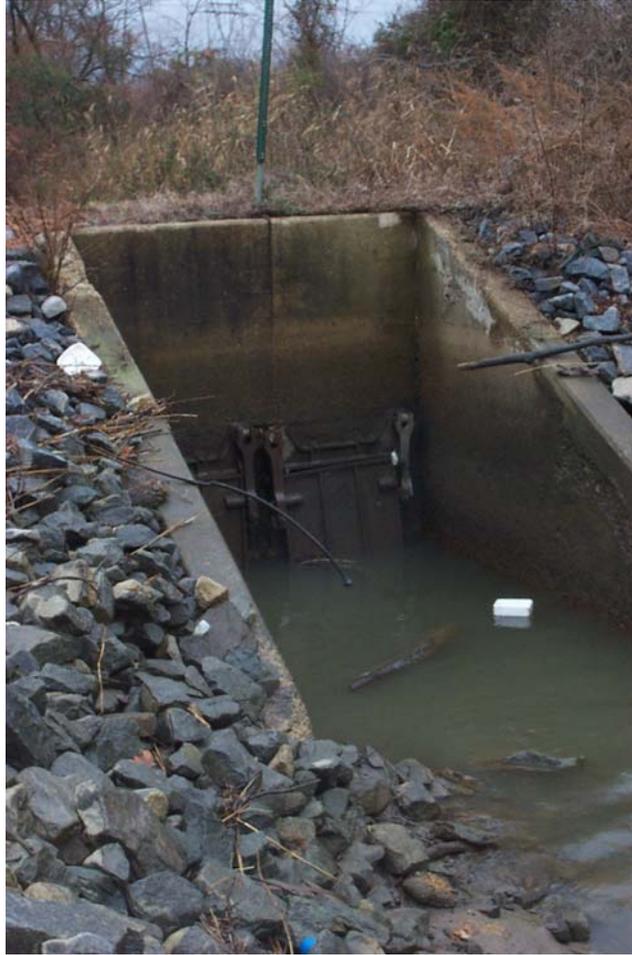
The storm drain system in A Street was constructed as part of improvements completed in 1992 to improve the drainage system. This portion of the work included the addition of inlets at the intersections of A Street with Claymont and Bradford Streets and separating the storm drain system from the combined system by adding a storm drain along A Street from Claymont Street to Christina Avenue. The storm drain system draining this area connects to a 42-inch pipe on the southwest side of Christina Avenue that also serves as the overflow pipe for CSO 9C. The 42-inch pipe follows Christina Avenue for approximately 300 feet until it connects with a twin 43-inch by 27-inch culvert crossing Christina Avenue, north of the railroad. This culvert outlets into a ditch draining to the east away from Christina Avenue and paralleling the railroad. There is a dike on the north side of this ditch and a railroad paralleling the ditch on the south side. This ditch continues to the Christina River where it connects to a junction chamber before emptying into the Christina River. There are two cast iron tide gates located at the outlet end of this structure. During a field investigation on January 3, 2006, it was determined that a hinge supporting one of the tide gates has separated from the concrete headwall.

Tide Gate East of Christina Avenue with Broken Hinge

This tide gate is probably no longer water tight and it is likely that Christina River flow could back up into the ditch during certain hydraulic conditions.

The recommendations for this site, therefore, include the installation of a 42-inch drain parallel to the existing to double the current hydraulic capacity. Also, it is recommended to repair the flap valve. Cleaning of the existing pipes, manholes and ditches is also recommended. The preliminary project cost for these recommendations is \$300,000. The proposed improvements are depicted on Figure 12 in Appendix A.

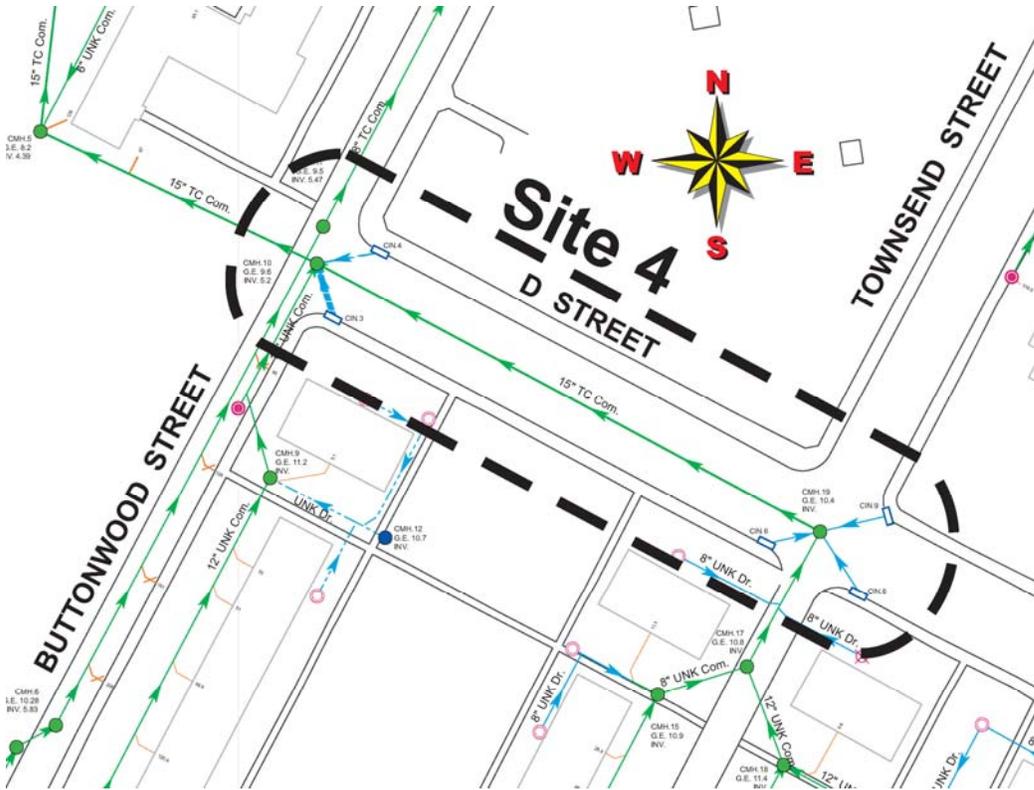
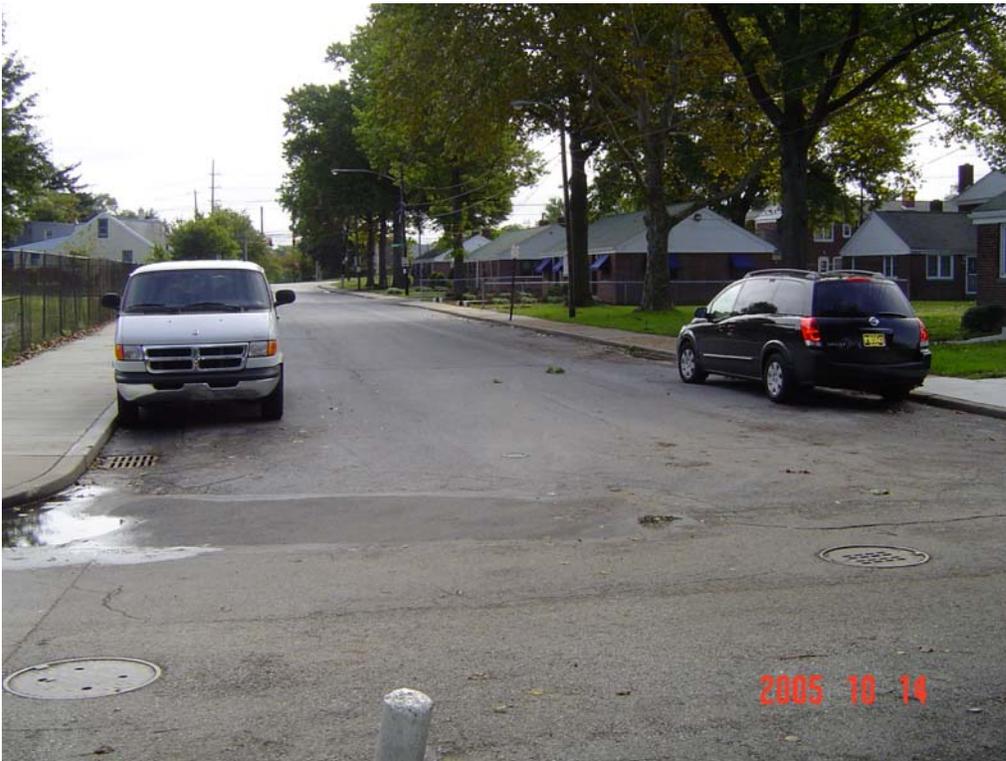
D Street near Buttonwood Street has also been identified as an area that experiences frequent flooding by local officials. It has been reported that water along D Street has reached the top of the curbs. This location is depicted on the next page and as Figure 7 in Appendix A. Roadway drainage along D Street flows from a high point at South Heald Street towards the west to its terminus at Buttonwood Street. Drainage from the South Heald Street bridge over the railroad drains onto D Street. Drainage along Elbert Place and Buttonwood Street flows to the north towards D Street. Inlets along D Street near South Heald Street drain into a separate storm drain system that flows south parallel to South Heald Street. Inlets from the intersection with Townsend Street to Buttonwood Street connect into a 15-inch combined sewer that eventually joins the 24-inch combined sewer that connects to CSO 10. Based on available information, there does not appear to be any inlets located along Buttonwood Street or Elbert Place south of D Street along the portions that would drain towards D Street.

D Street at Buttonwood Street

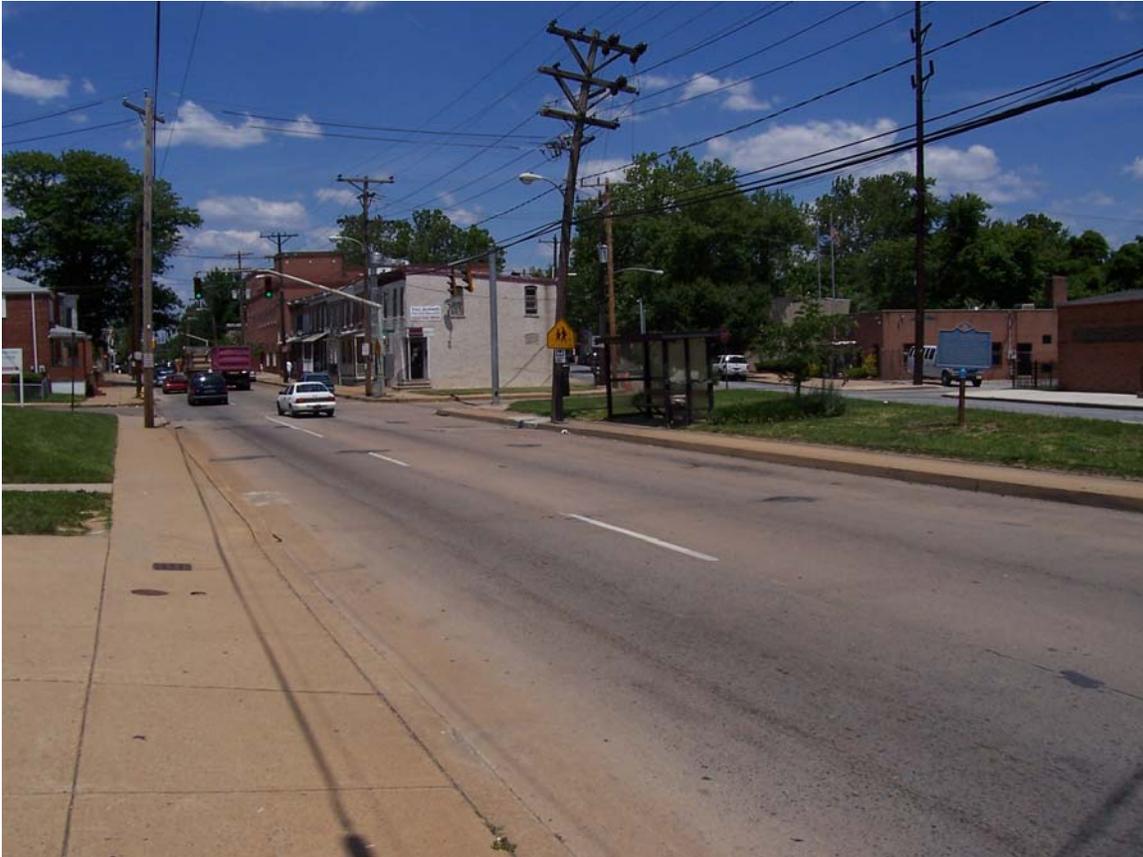
The roadway elevation at this low point is approximately 5.3 feet based on the available topography. There are two inlets, one on each side of the street, at or near this low point. Roadway drainage flows to this low point from a high point located just north of B Street to a high point to the south located approximately 350 feet south of Terminal Avenue. In the area of the intersection with D Street, the grade along New Castle Avenue appears to be flat and there may be an intermediate low point in this area. A portion of the roadway drainage from New York Avenue flows onto New Castle Avenue and towards the flooding area. D Street from Heald Street to New Castle Avenue drains to New Castle Avenue. Approximately 200 feet of Pearl Street to the west of New Castle Avenue drains towards New Castle Avenue. C Street drains towards New Castle Avenue starting at Townsend Street. The inlets at the low point near C Street connect to a storm drain system that parallels C Street and empties into a ditch that leads to a culvert that crosses Christina Avenue just north of the railroad. This is the

New Castle Avenue at C Street

Based on available information, the preliminary recommendation is to inspect and clean all of the inlets and pipes. The preliminary project cost for this recommendation is \$50,000. The proposed improvements are depicted on Figure 13.

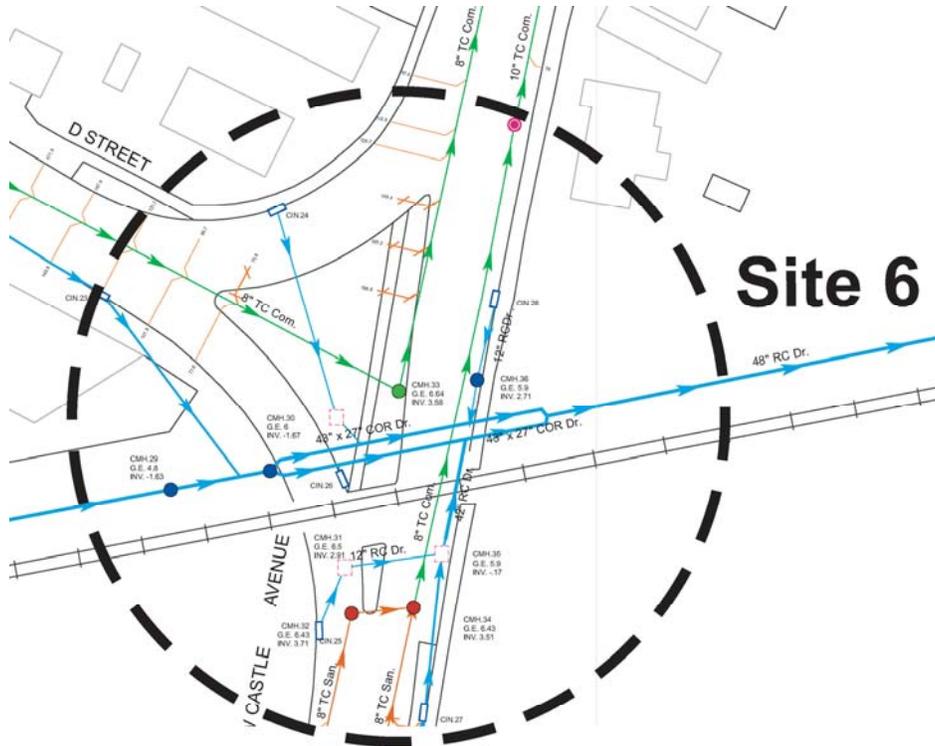
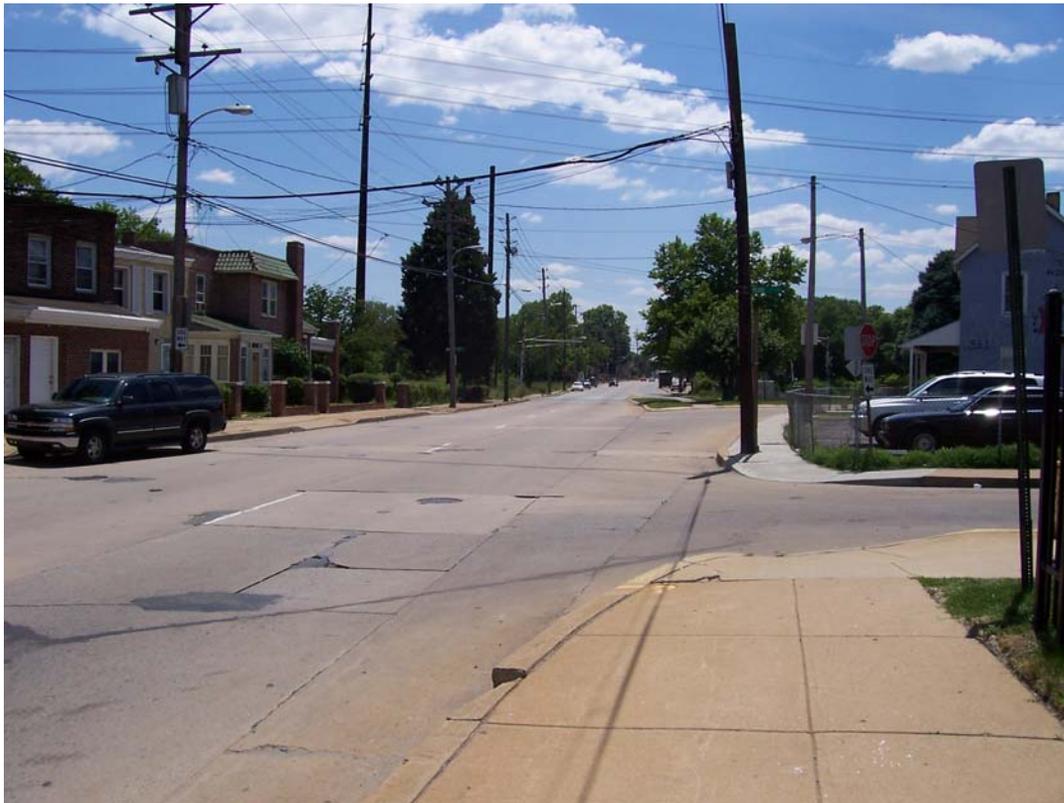
The roadway grades at the intersection of New Castle Avenue and D Street are located in a low area. This is another area that has been reported by local officials to experience frequent flooding. This site is depicted on the next page and as Figure 8 in Appendix A. There is a twin 43-inch by 27-inch pipe crossing New Castle Avenue at this location just north of the railroad. This culvert drains the area from the south including the traffic loop near Garasches Lane, part of D Street, New Castle Avenue to the south from near Terminal Avenue, and the Southbridge Extension.

New Castle Avenue at D Street

Similar to Site 5, it appears that the primary cause of flooding at this site is clogged inlets and/or pipes. The storm drainage system drains into a twin corrugated metal culvert under New Castle Avenue. The planned CCTV inspection will determine the conditions of this culvert. If it is clogged and/or deteriorated, this would contribute to the drainage problem. As noted before, three of the inlets along this drainage system are completely clogged.

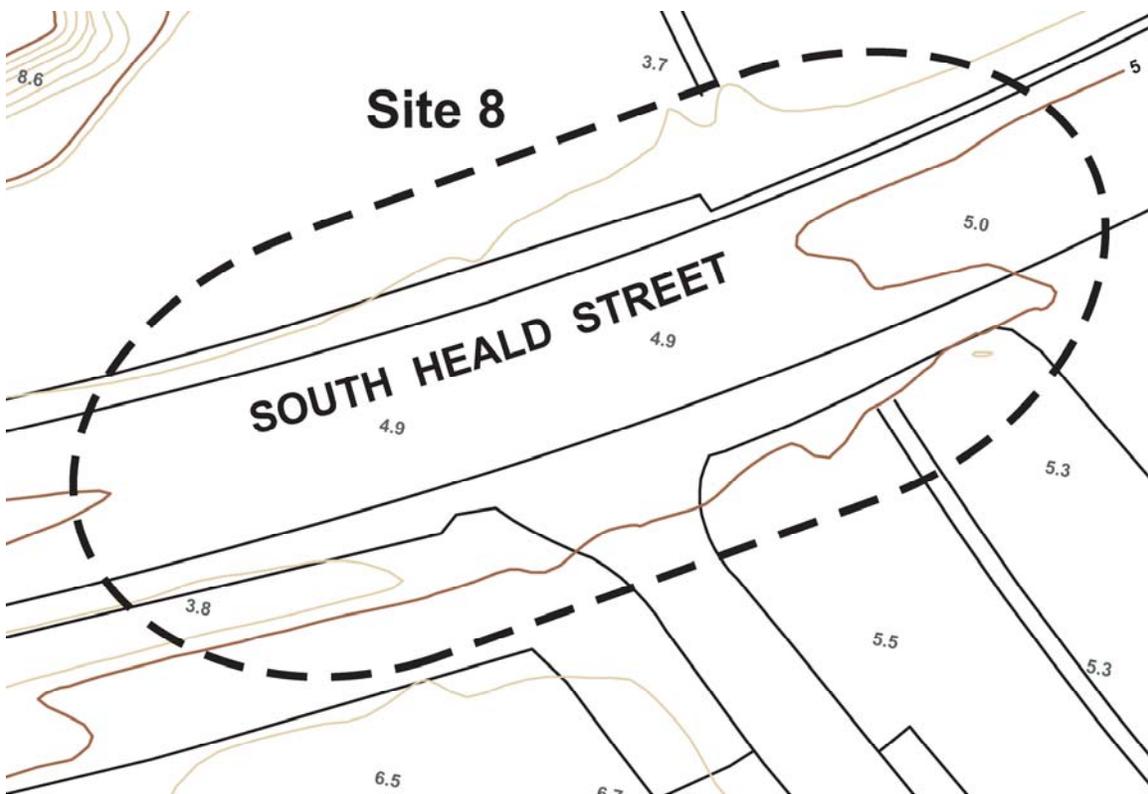
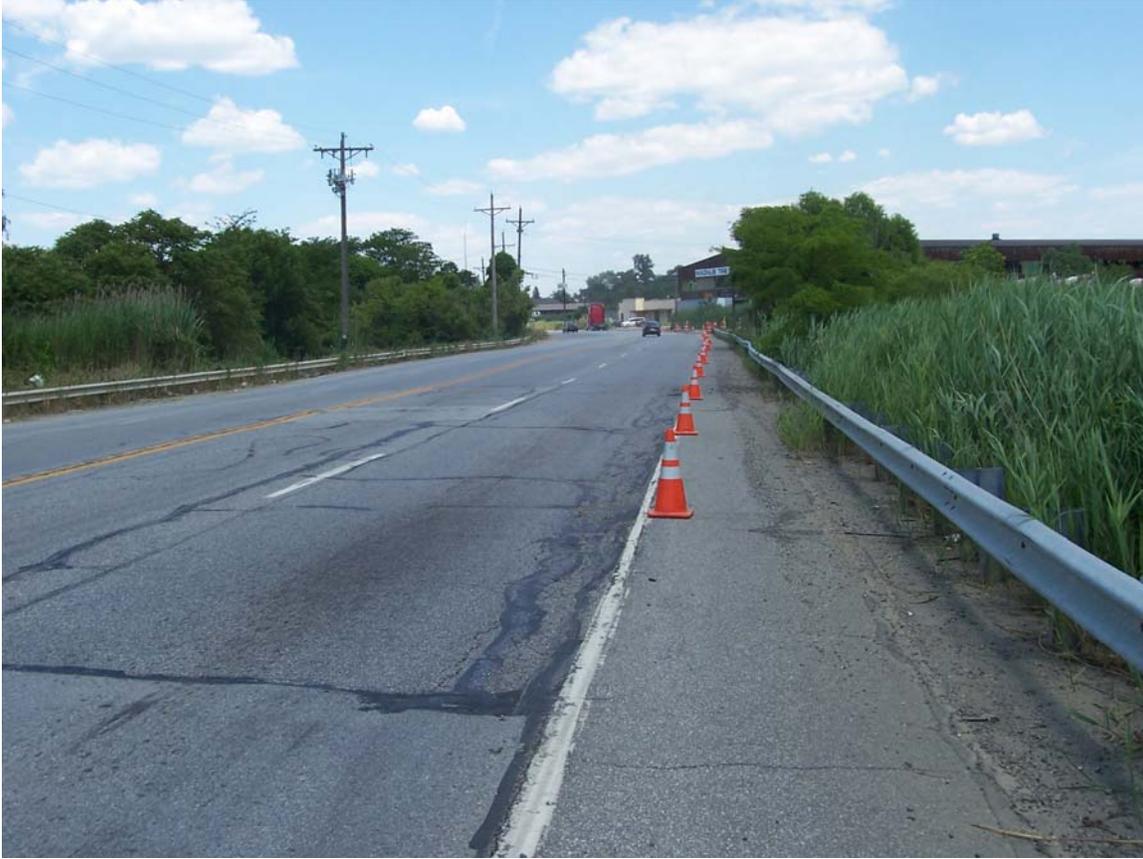
South Heald Street near Magnus Tire is located approximately 1,200 feet east of Market Street and 1,000 feet north of I-495. This area floods frequently and there is a roadway sign warning motorists of the flooding hazard. This site is below and as Figure 10 in Appendix A. South Heald Street at this location consists of a bridge over the waterway. The drainage area extends to the south to the other side of I-495. This area is located at a low point in the roadway at an elevation of approximately 4.9. Downstream of South Heald Street there is a wide waterway that extends from South Heald Street to the railroad. The flow drains into a ditch paralleling the railroad. During a field investigation along the railroad, it was noticed that portions of the flow from this area were seeping through the railroad ballast to the ditch on the north side of the railroad. The ditch along the railroad drains to the west to the Christina River through a tide gate. There may be a pipe or pipes installed under the railroad that drains through the area to the north outleting at Garasches Lane, but this has not been confirmed to date. The pipe, if it exists, may be collapsed or clogged.

South Heald Street near Magnus Tire

Replace or repair the culverts under the railroad, clean the ditches along the railroad and re-establish the ditch downstream of the railroad through the junkyard on the north side of the railroad.

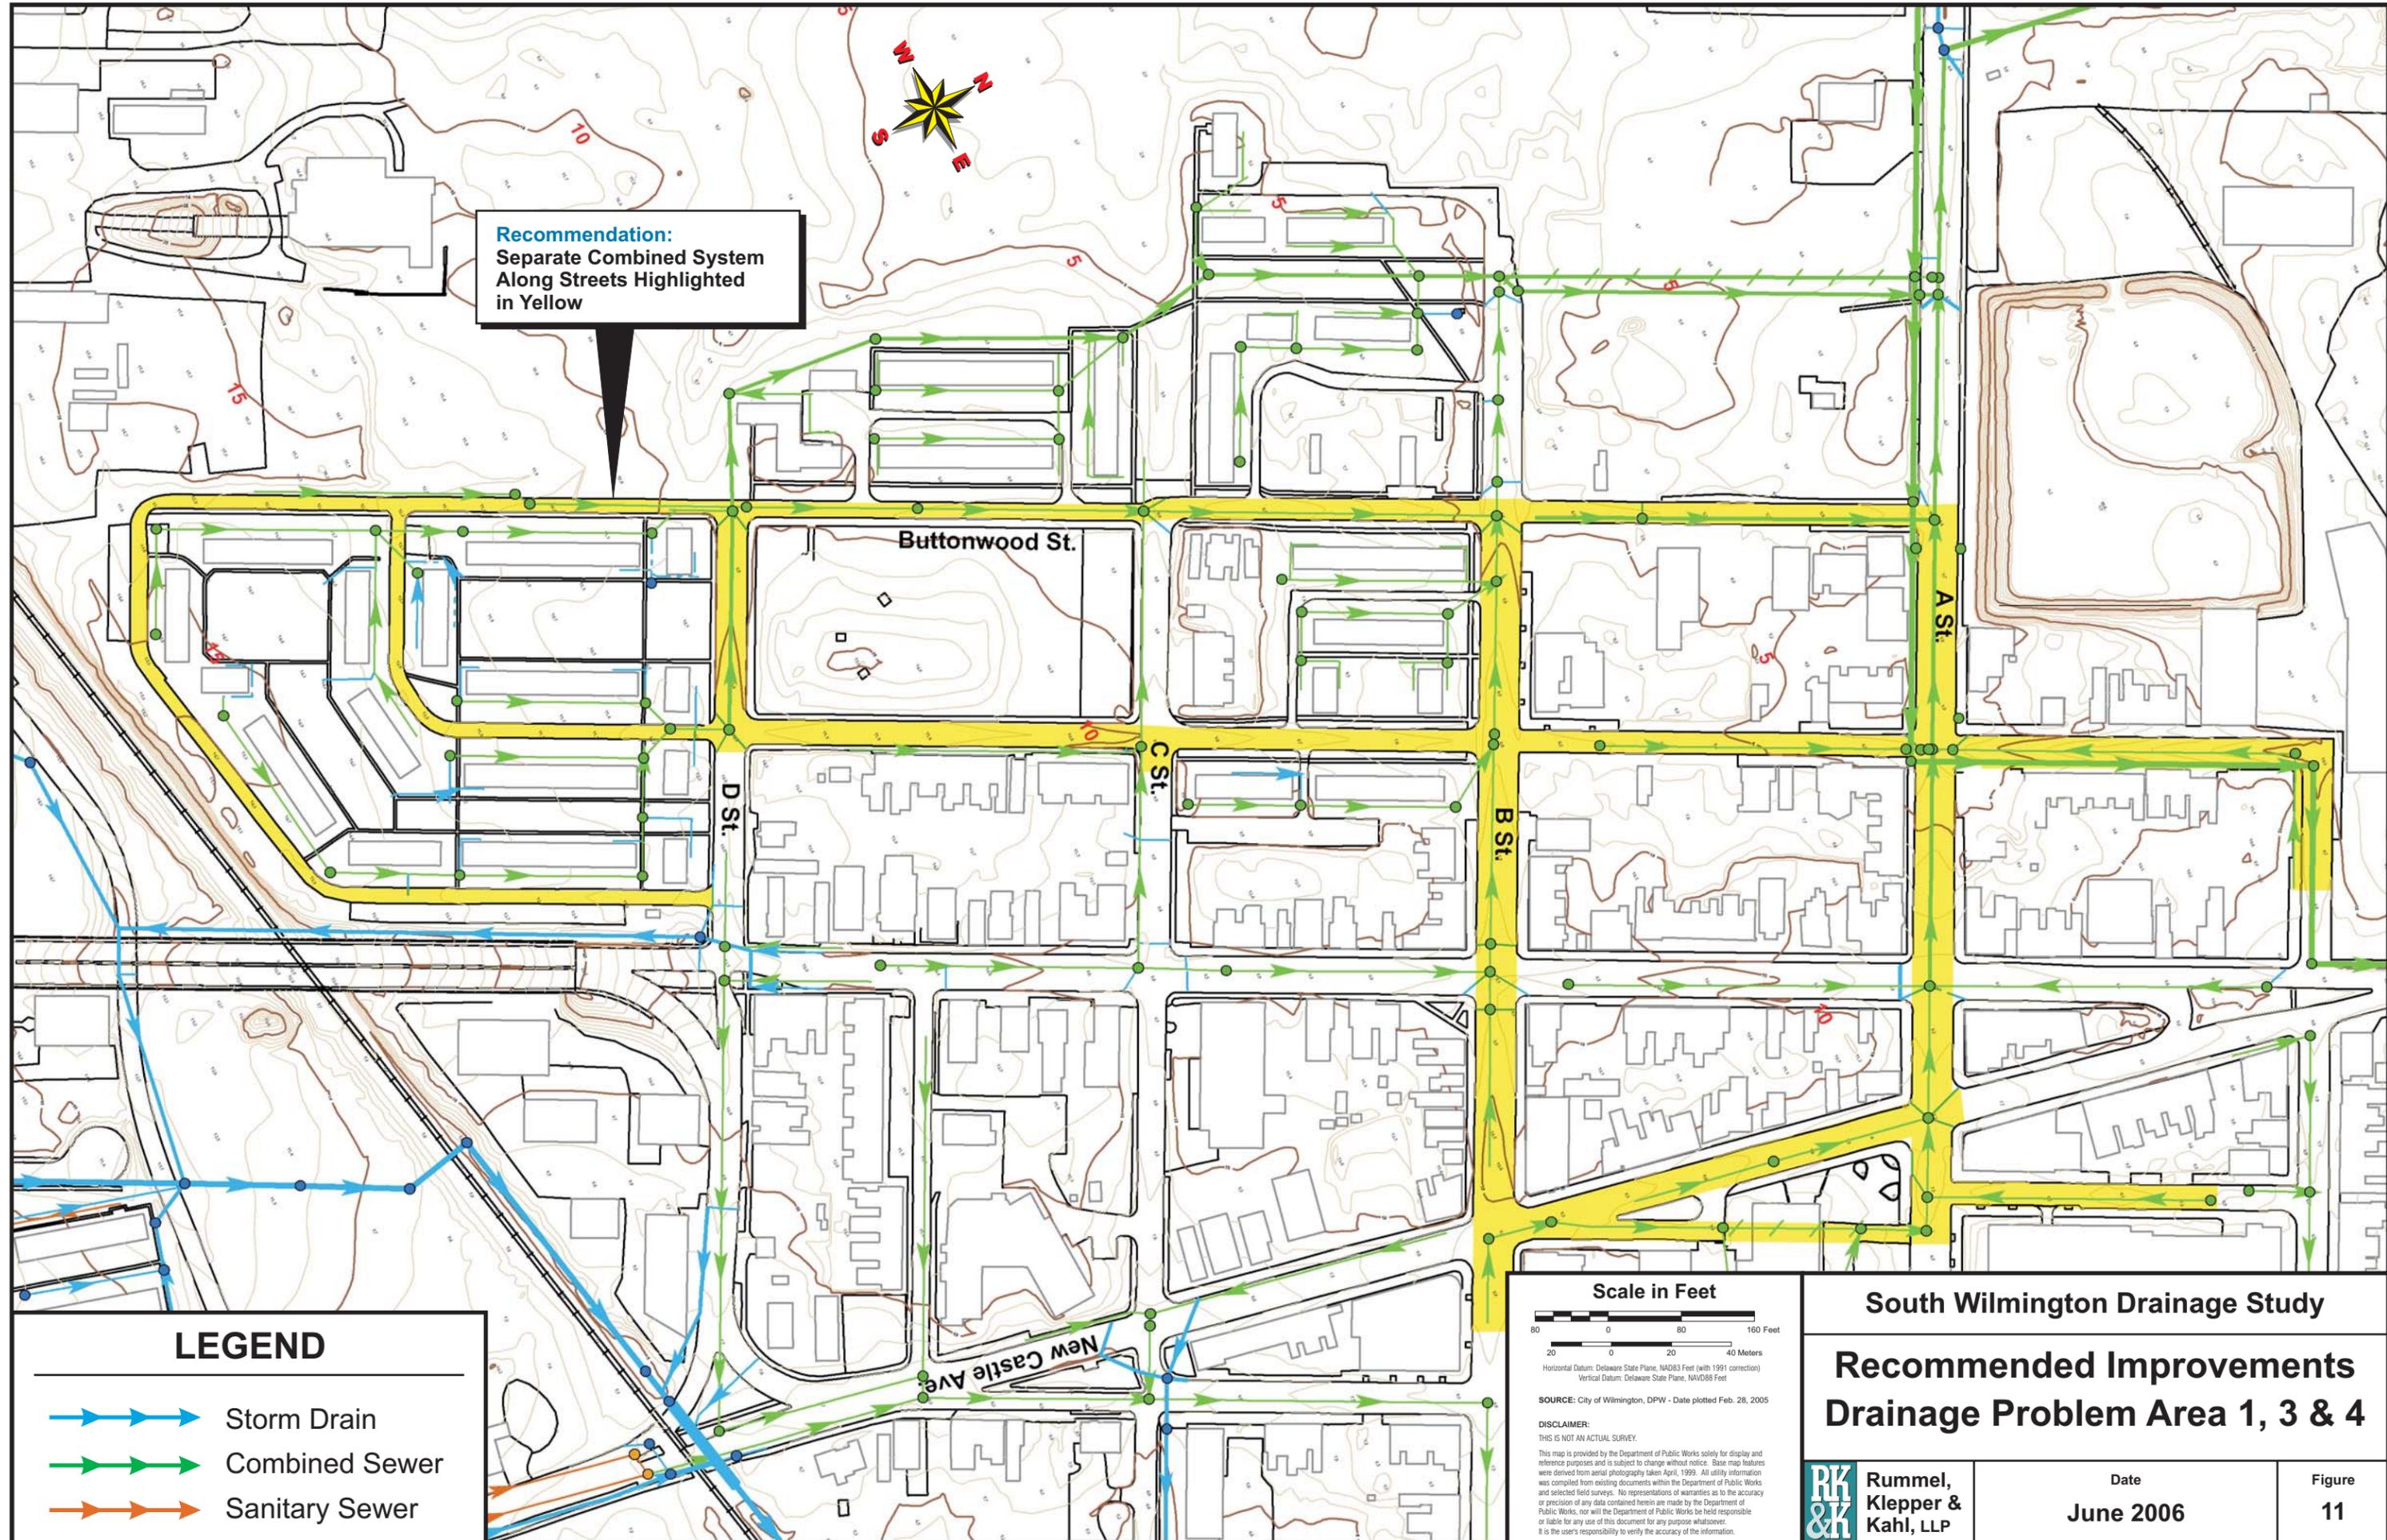
**Recommendation:**  
Separate Combined System  
Along Streets Highlighted  
in Yellow

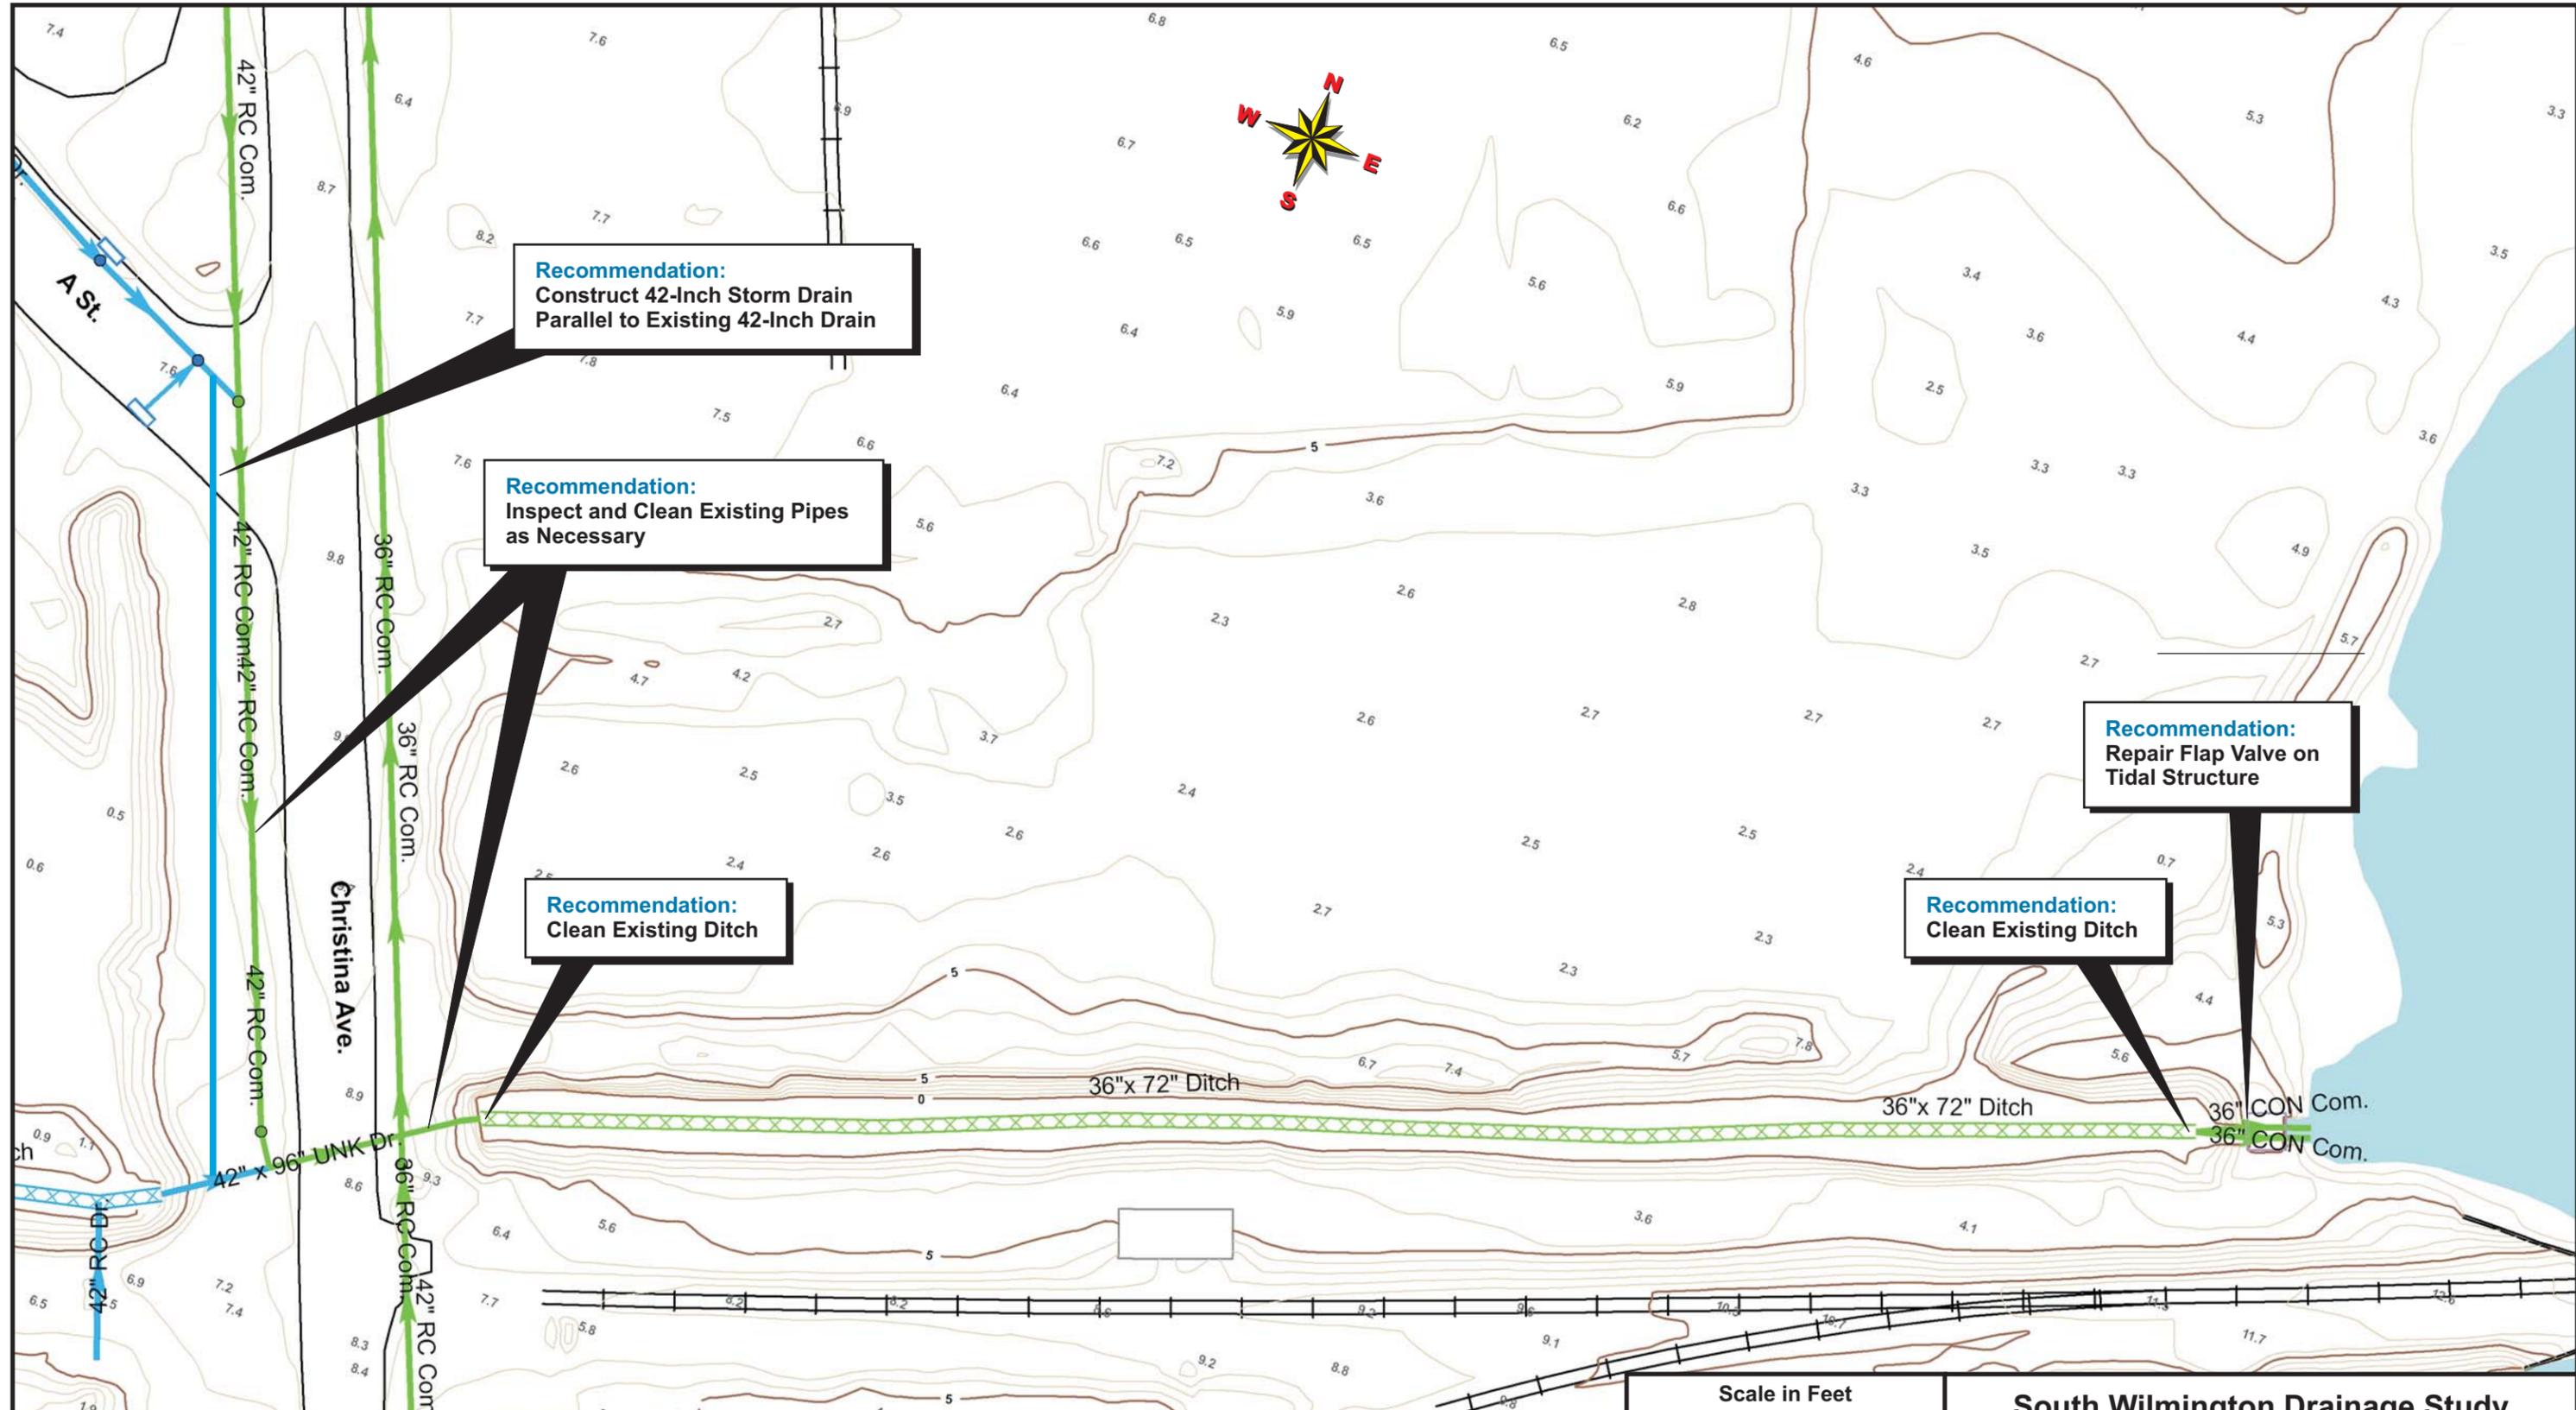
<b>Rummel, Klepper &amp; Kahl, LLP</b>	Date <b>June 2006</b>	Figure <b>12</b>
--	--------------------------	---------------------

**Recommendation:**  
Clean Existing Ditch

**Recommendation:**  
Repair Flap Valve on  
Tidal Structure
