# SOUTH WILMINGTON DRAINAGE STUDY

Prepared by  
**Rummel, Klepper & Kahl, LLP**

**For the City of Wilmington, Department of Public Works**

Subject: Final Engineering Report

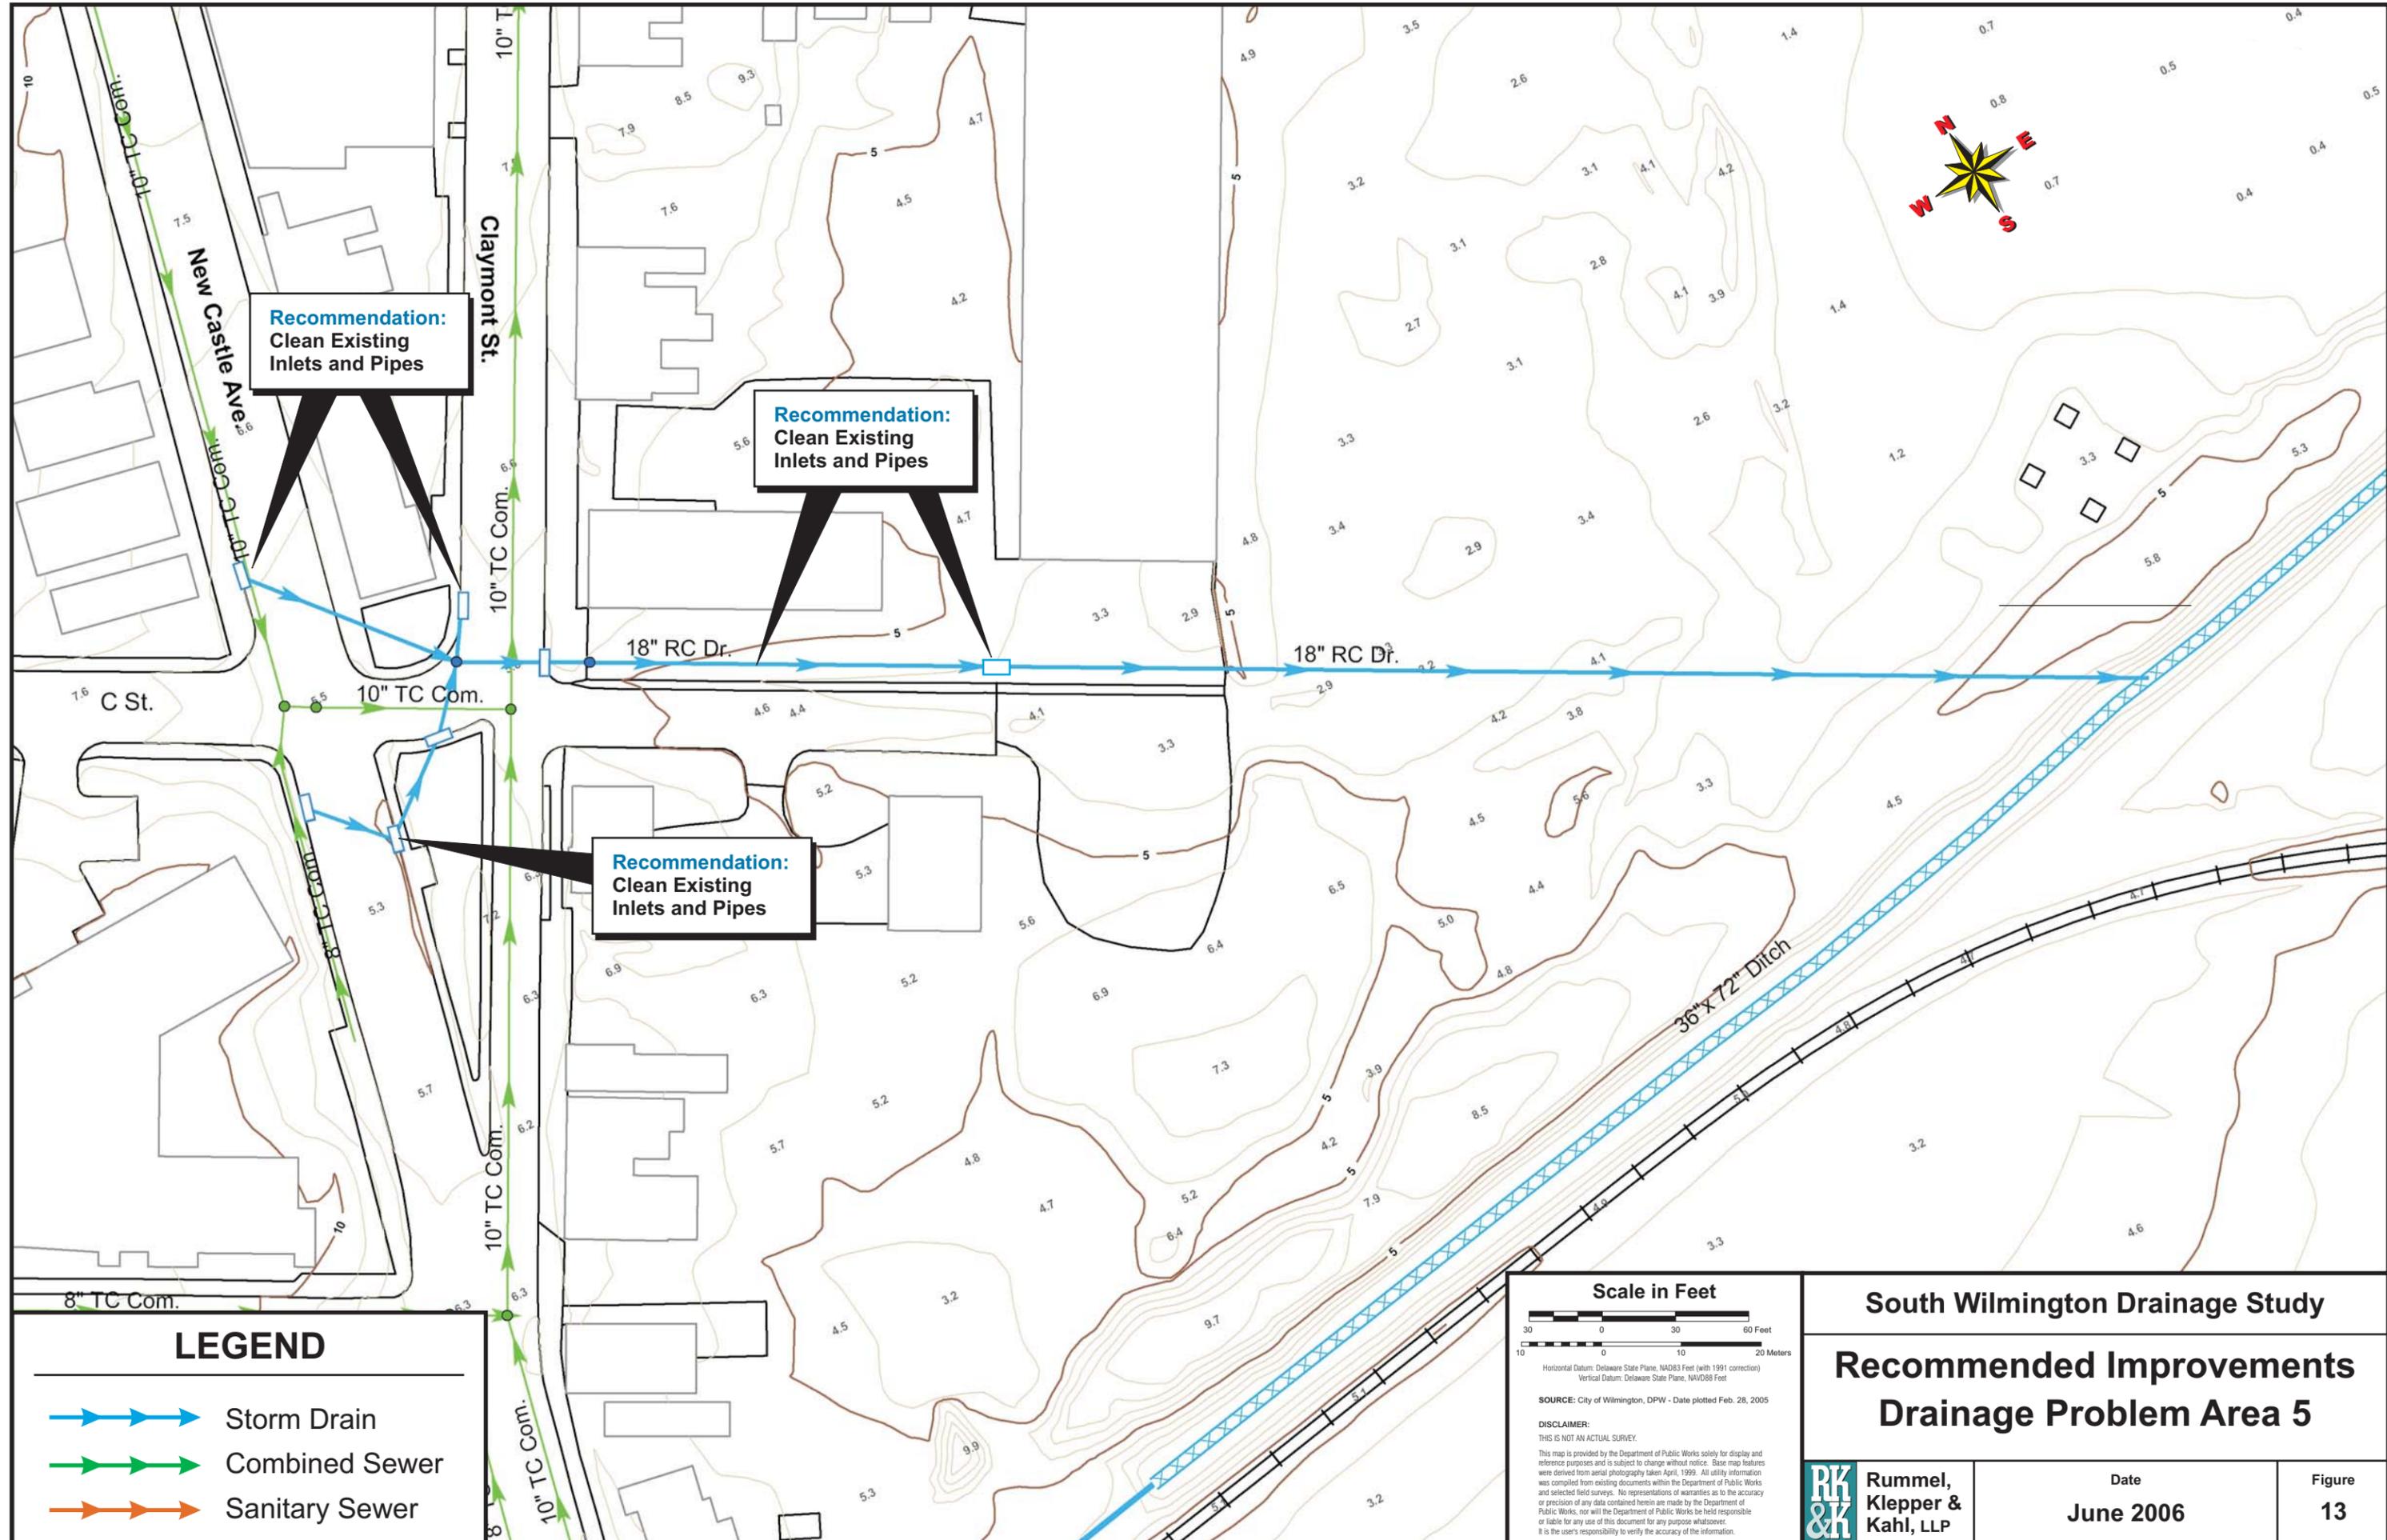
<b>Rummel, Klepper, &amp; Kahl, LLP</b>	Date	Figure
	June 2006	13

**Recommendation:**  
Clean Existing  
Inlets and Pipes

Based on available information, the preliminary recommendation is to inspect and clean all of the inlets and pipes. The preliminary project cost for this recommendation is \$50,000. The proposed improvements are depicted on Figure 13.

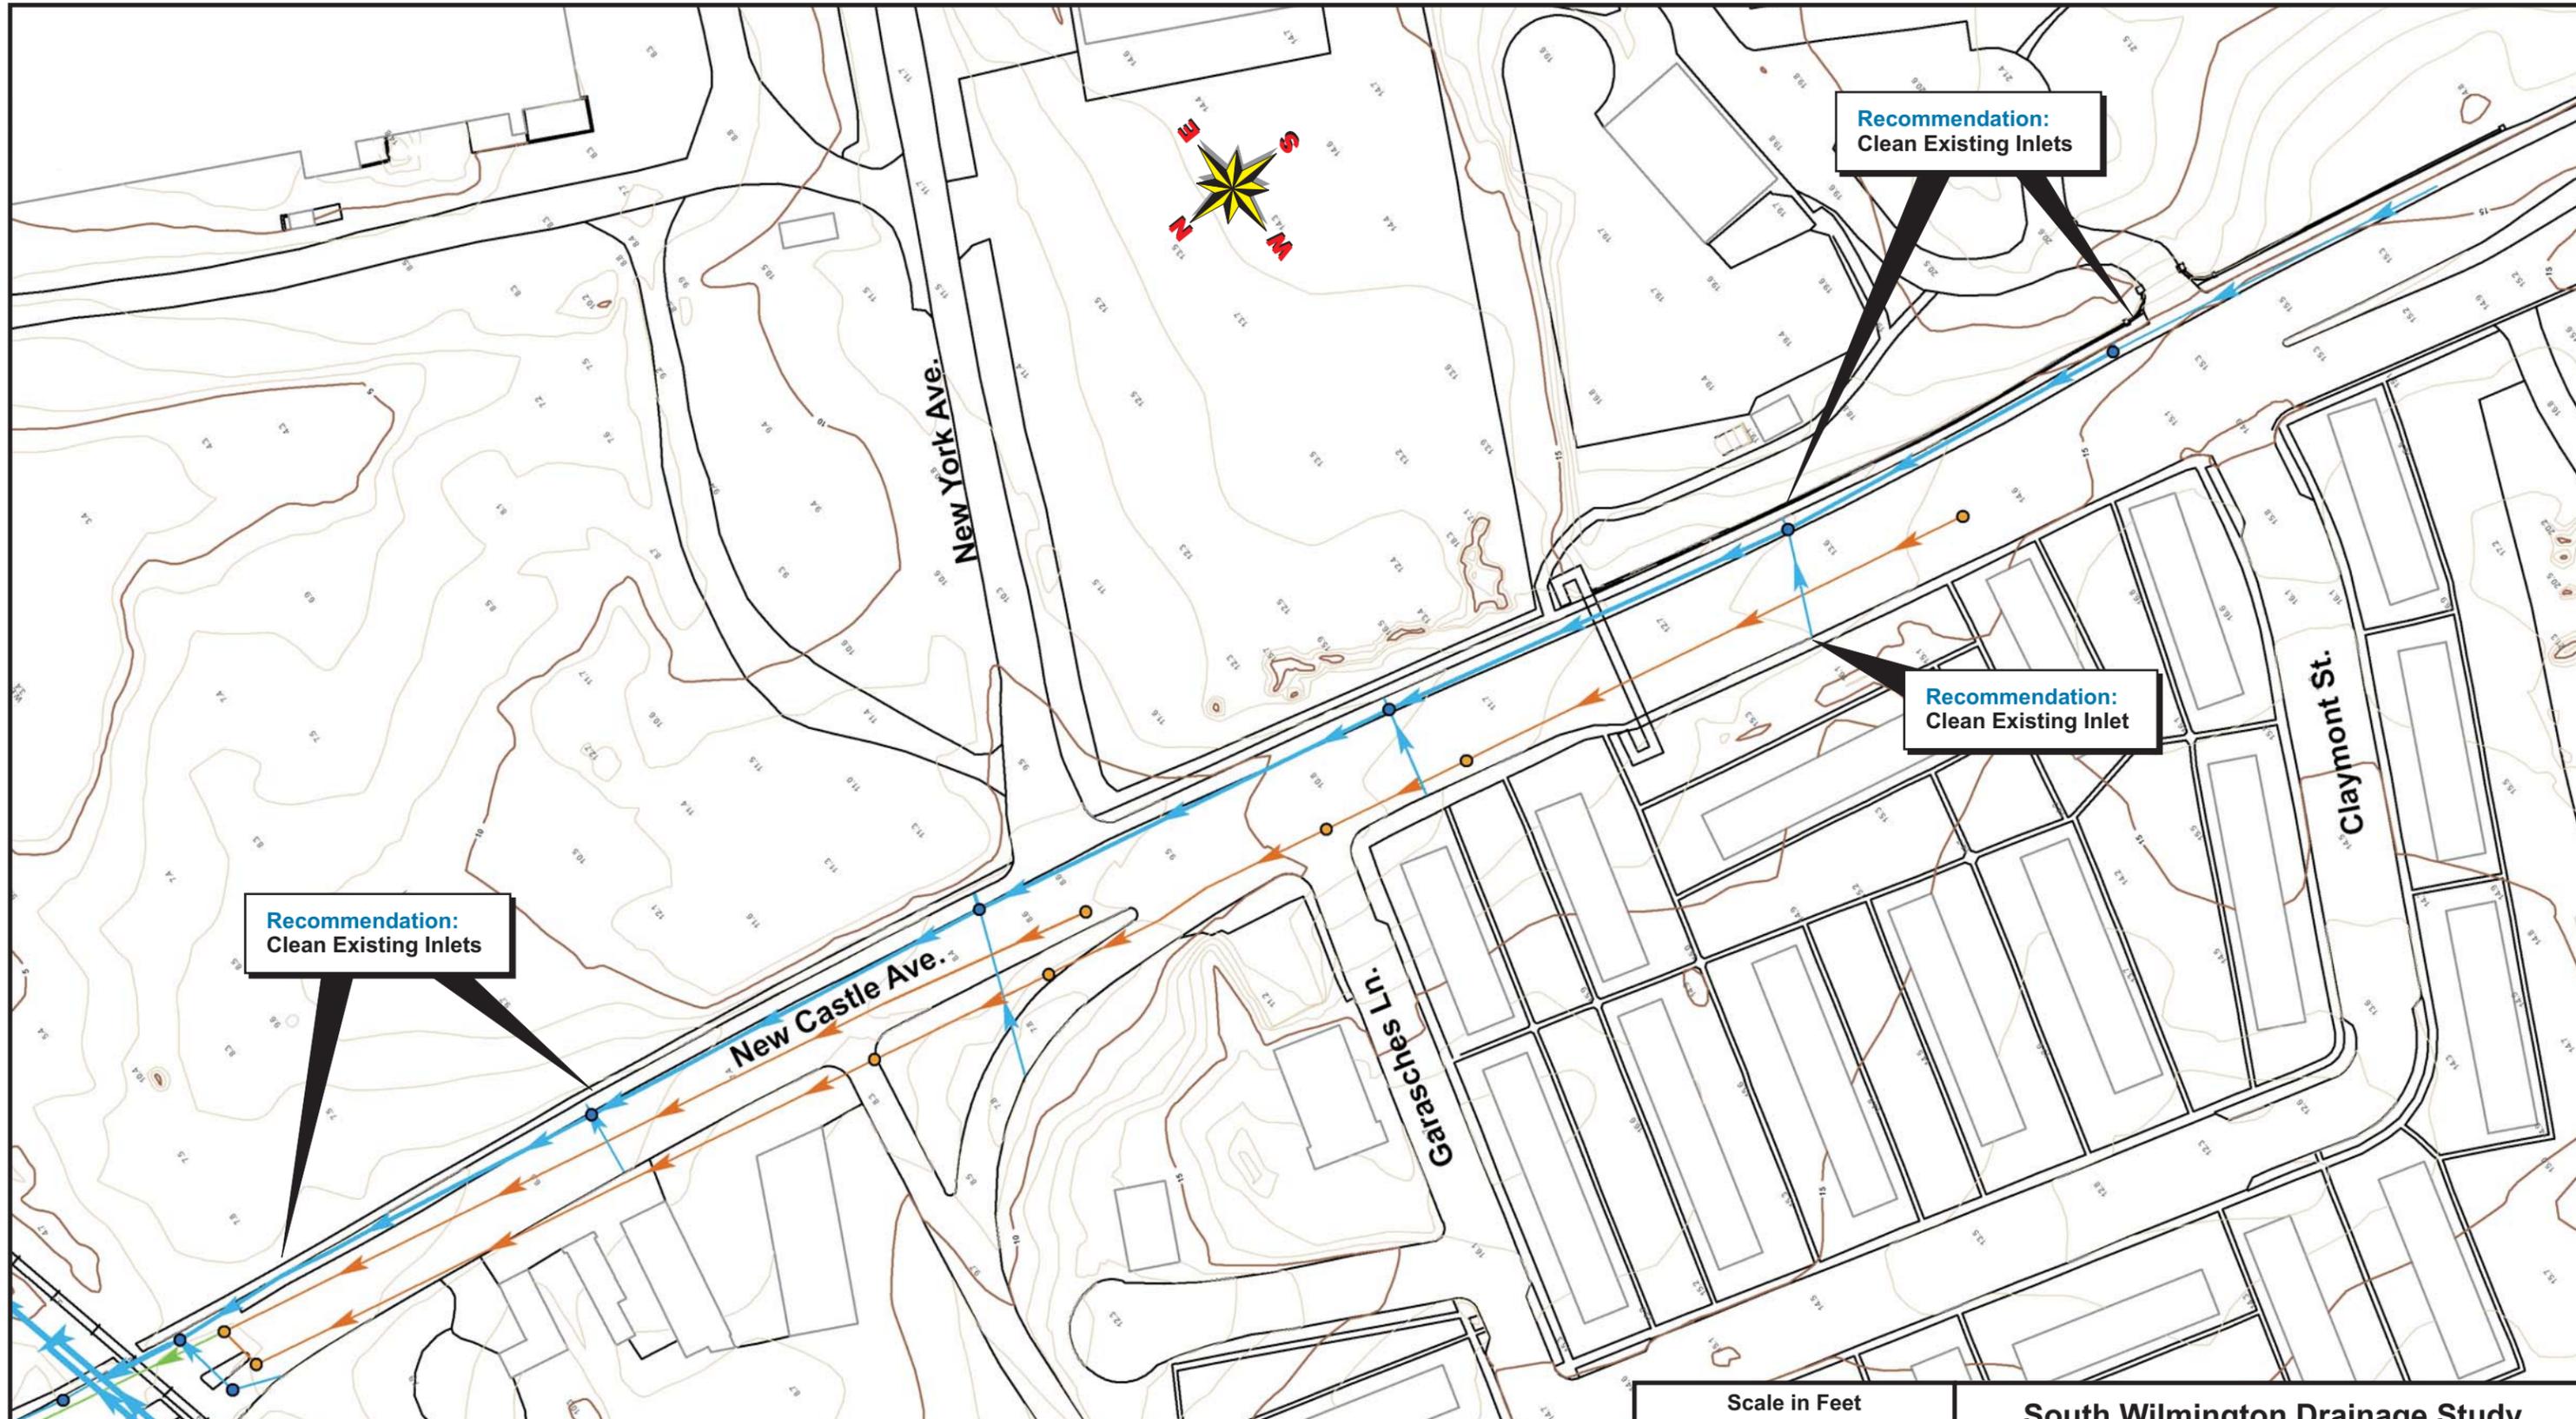
<b>Rummel, Klepper &amp; Kahl, LLP</b>	Date	Figure
	June 2006	14

**Recommendation:**  
Clean Existing Inlets

Similar to Site 5, it appears that the primary cause of flooding at this site is clogged inlets and/or pipes. The storm drainage system drains into a twin corrugated metal culvert under New Castle Avenue. The planned CCTV inspection will determine the conditions of this culvert. If it is clogged and/or deteriorated, this would contribute to the drainage problem. As noted before, three of the inlets along this drainage system are completely clogged.

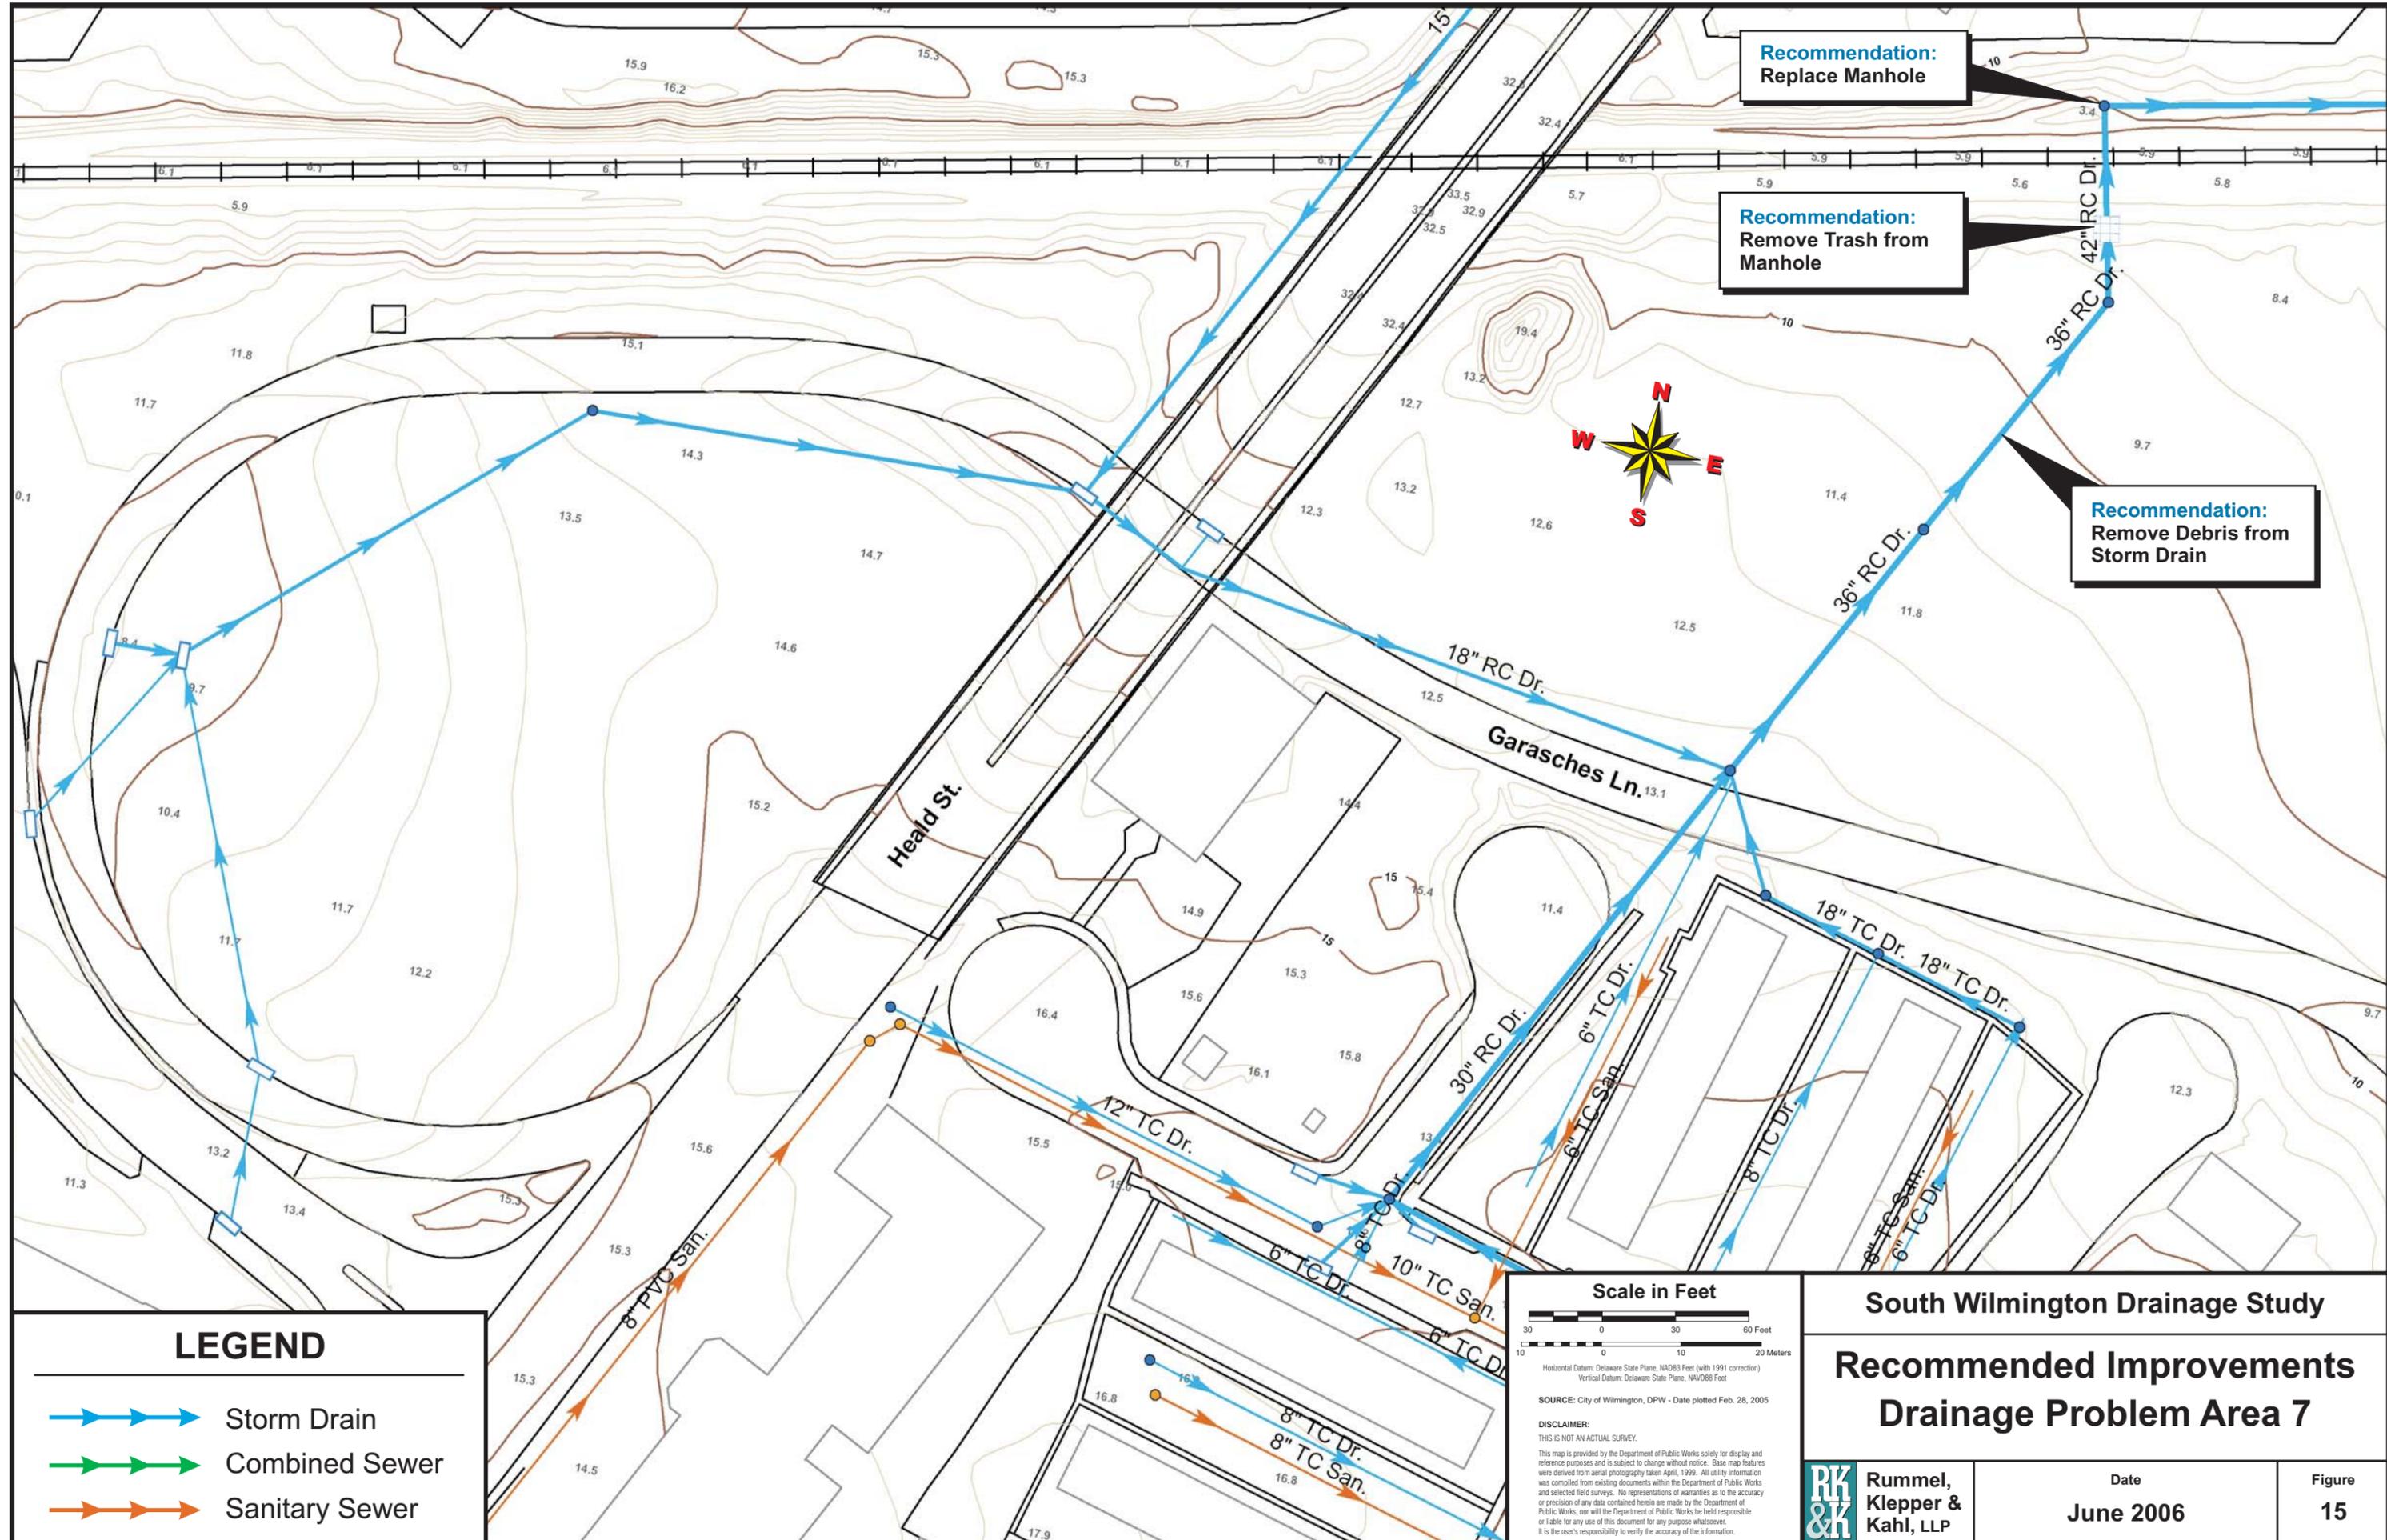
<b>Rummel, Klepper &amp; Kahl, LLP</b>	Date	Figure
	June 2006	15

**Recommendation:**  
Replace Manhole

**Recommendation:**  
Remove Trash from  
Manhole

**Recommended Improvements  
Drainage Problem Area 7**

Remove trash from the manholes. Repair or replace the manhole on the north side of the railroad. Once the planned internal television inspections of the storm drains are completed, additional recommendations may be made depending on the condition of the system.

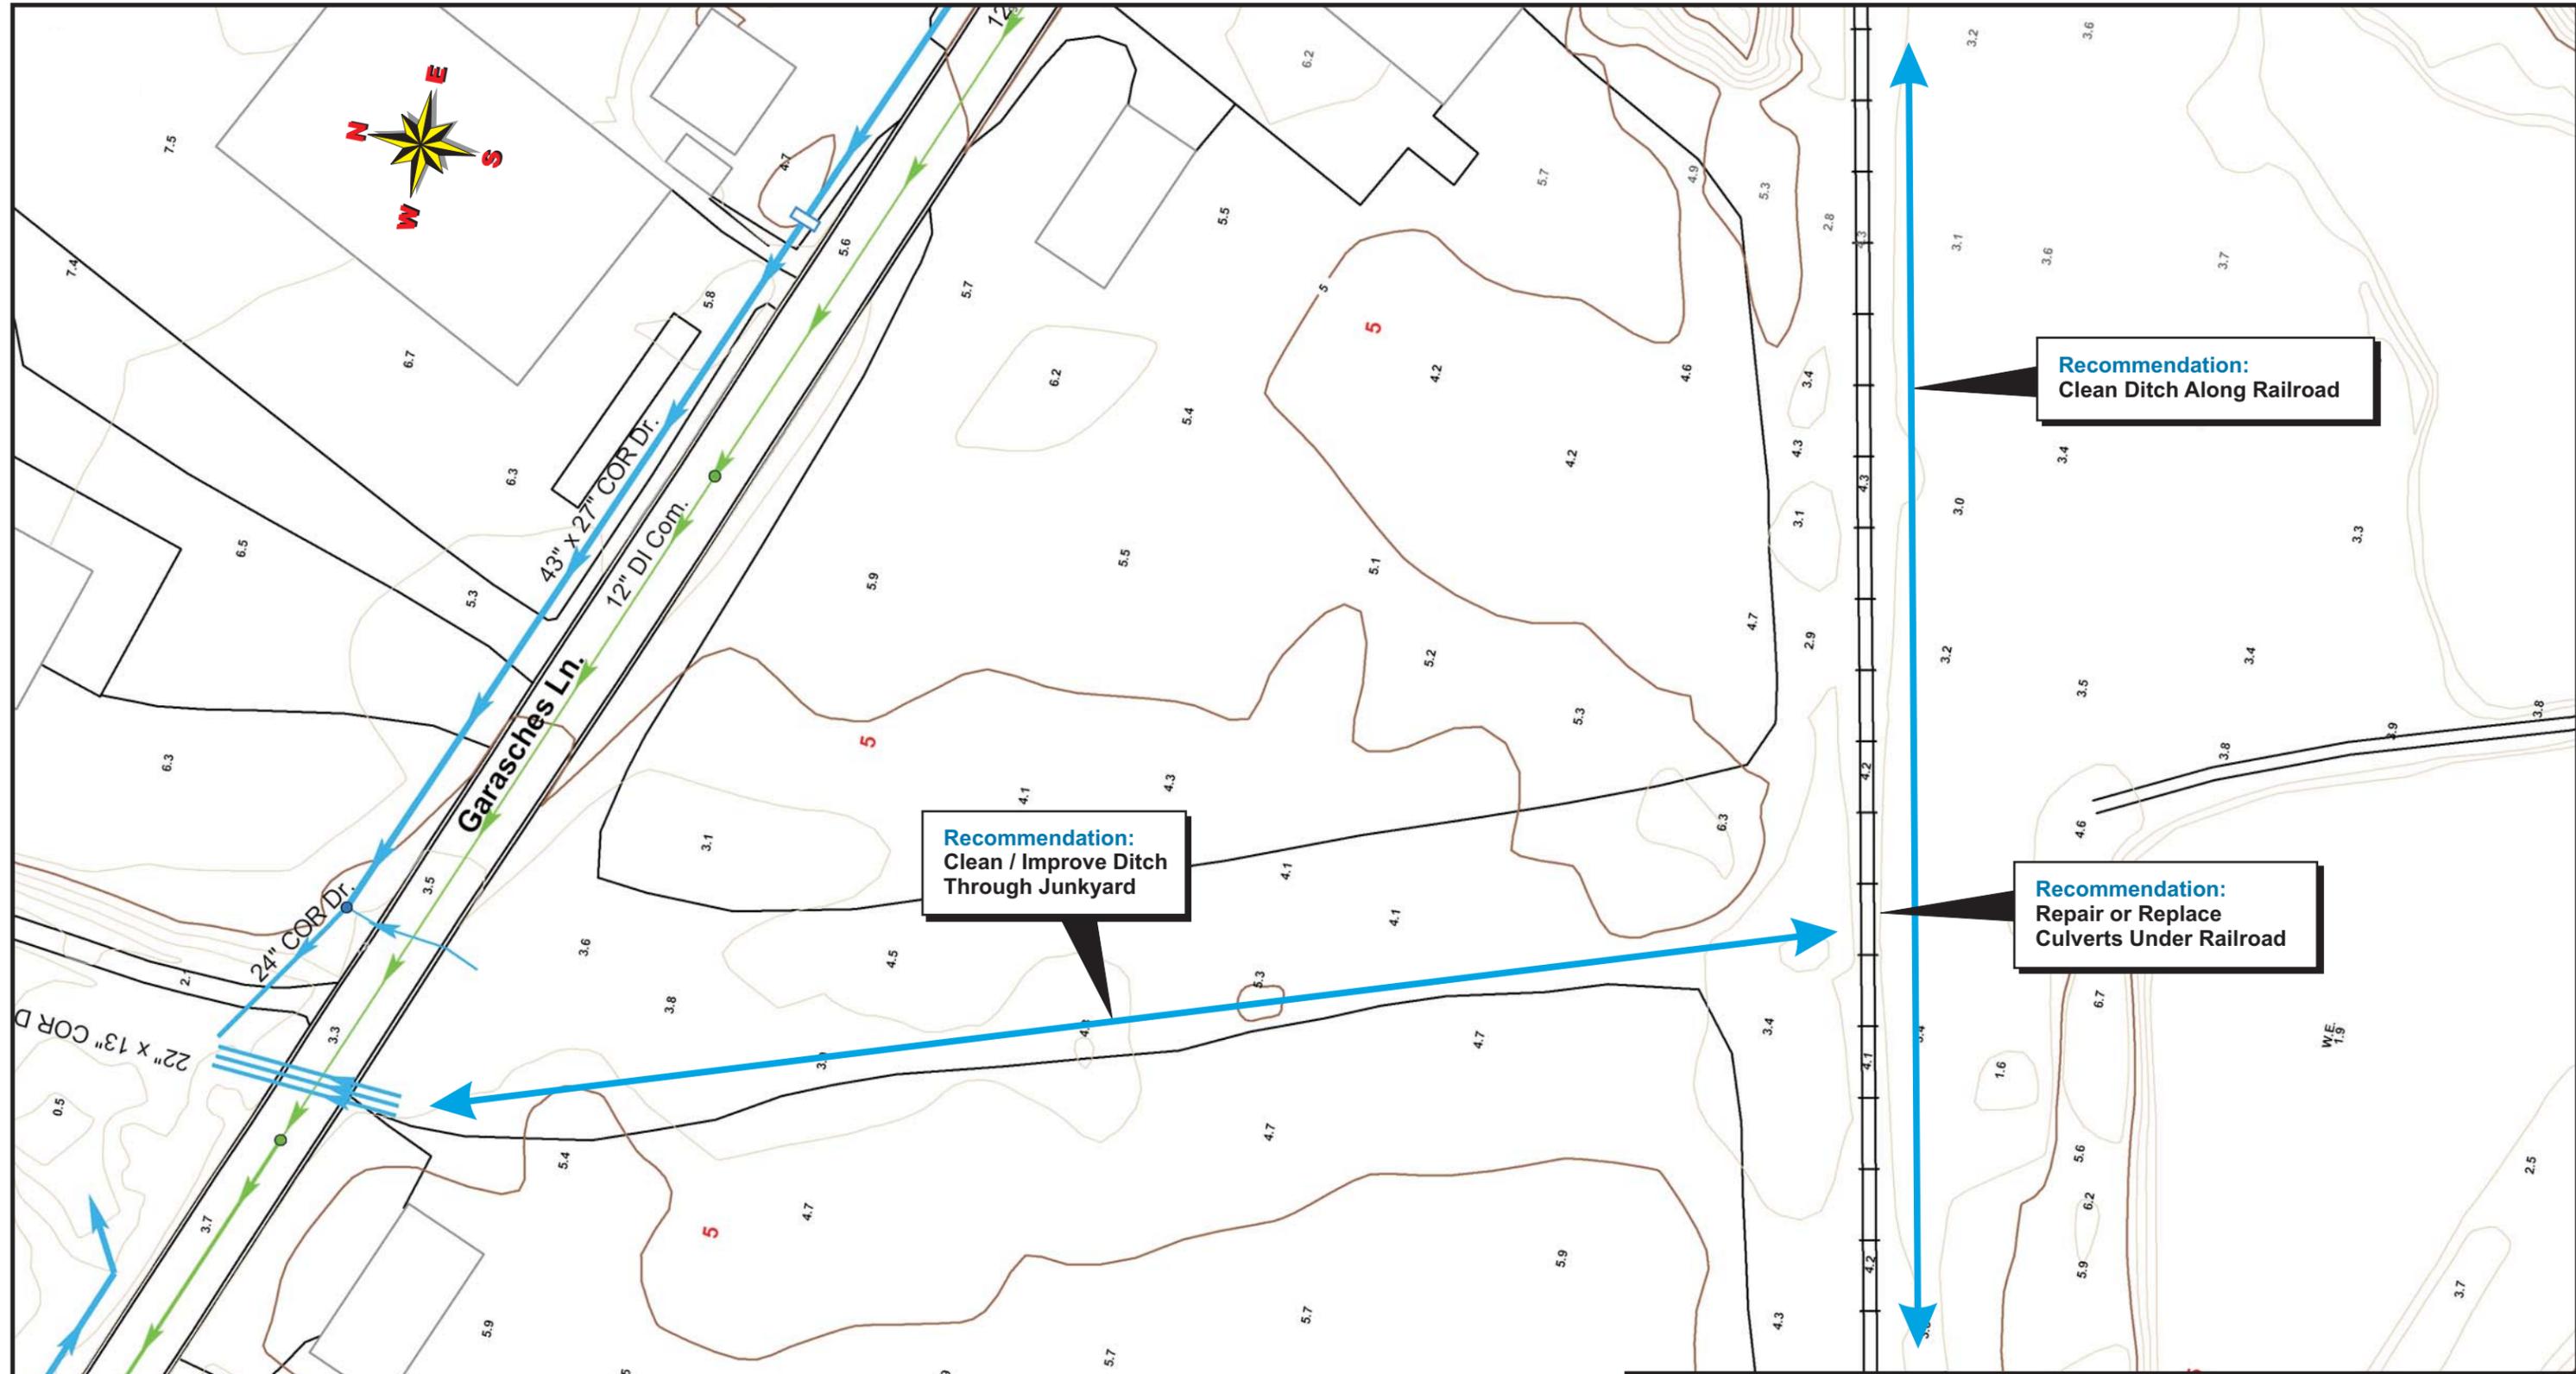
**Recommendation:**  
Clean / Improve Ditch  
Through Junkyard

**Recommendation:**  
Clean Ditch Along Railroad

Replace or repair the culverts under the railroad, clean the ditches along the railroad and re-establish the ditch downstream of the railroad through the junkyard on the north side of the railroad.
